BMW 2 ACTIVE TOURER: 1LTN023

Limited Technical Inspection

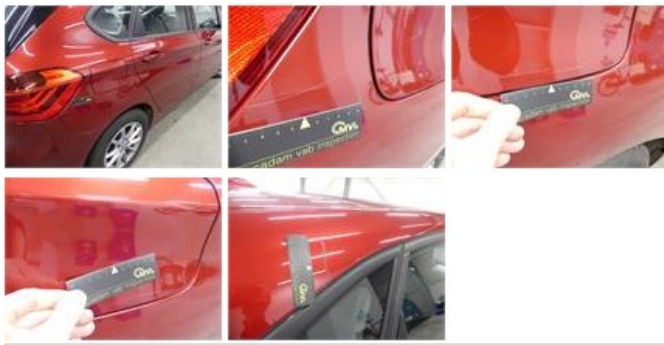
Repair kit	Yes	Compressor	Yes
Total cost ex VAT			961,55
Wing F R, Dent(s) and scratch(es), Acceptable			0,00
<i>No pictures to display</i>			
Bumper R, Scratch(es), Acceptable			0,00
<i>No pictures to display</i>			
Wing R R, Scratch(es), LI - Repair and paint (complete)			308,20

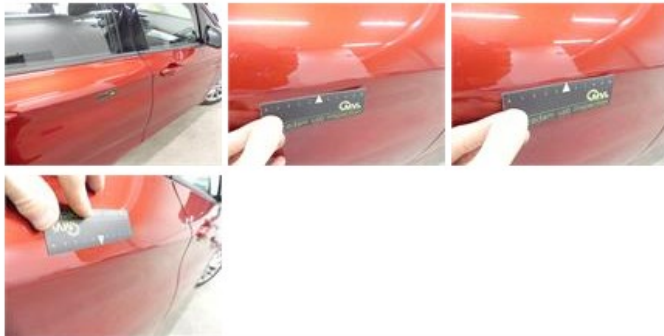
Bumper F, Scratch(es), Acceptable	0,00
<i>No pictures to display</i>	
Alloy rim R L, Scratch(es), Acceptable	0,00
<i>No pictures to display</i>	
Trunk lid covering R, Scratch(es), Acceptable	0,00
<i>No pictures to display</i>	
Rearlight R , Scratch(es), Acceptable	0,00
<i>No pictures to display</i>	
Door R R, Scratch(es), LI - Repair and paint (complete)	318,35

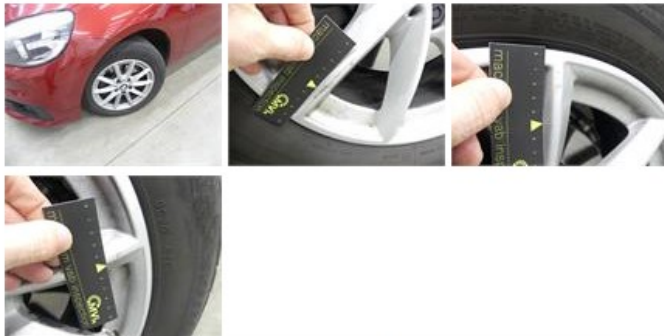
Alloy rim F L, Scratch(es), LI - Repair and paint (complete)	95,00
--	-------

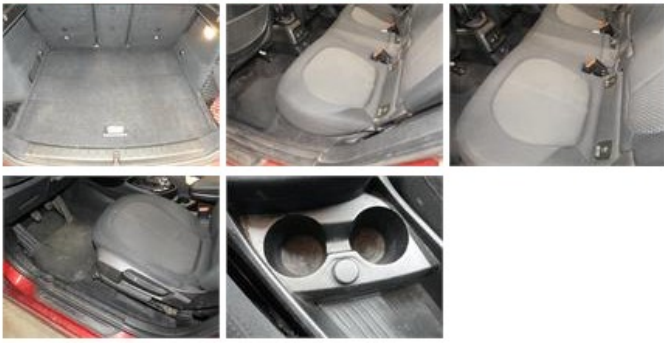
Interior, Dirty, Cleaning	50,00
---------------------------	-------
