MERCEDES GLE: 1PZA414

Limited Technical Inspection

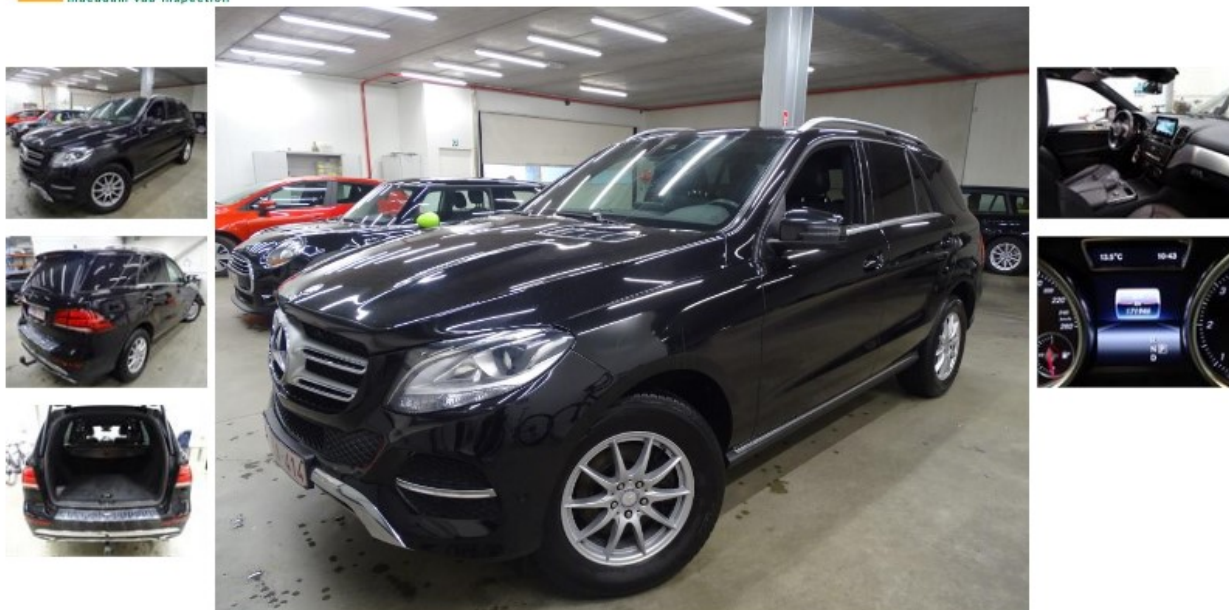
Vinnumber:	WDC1660041A832975	Versionname:	2.1 GLE 250 D 4MATIC
First Registrationdate:	17/10/2016	Fiscalpower:	
Expertise Mileage:	171946	Power Kw:	150
Bodytype:		Body color:	Black
Gearbox:	Automatic	Paint type:	Metalic
Transmission:	4 Weel	Rims summer:	Aluminium
Fueltype:	Diesel	Oil level:	OK
Battery functioning:	Yes	Parking lot:	3609
Number of doors:	5		
Number of seats:	5		
Number head rests:	5		
Rims summer:	Aluminium		
Category:	Passenger Car		
Oil level:	OK		
Registration Certificate Car (BE):	Yes
