SKODA Octavia: 1JFH103

Limited Technical Inspection

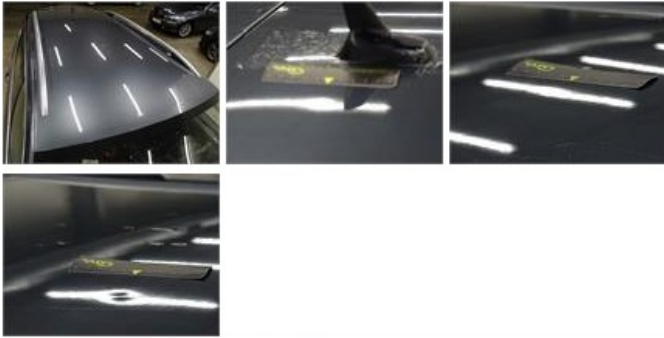
<i>No pictures to display</i>	
Bumper R, Scratch(es), 67 - Polish	0,00
<i>No pictures to display</i>	
Roof, Dent(s), PDR - Paintless dent repair	102,60
