LU Volkswagen Polo: EM5975

Limited Technical Inspection

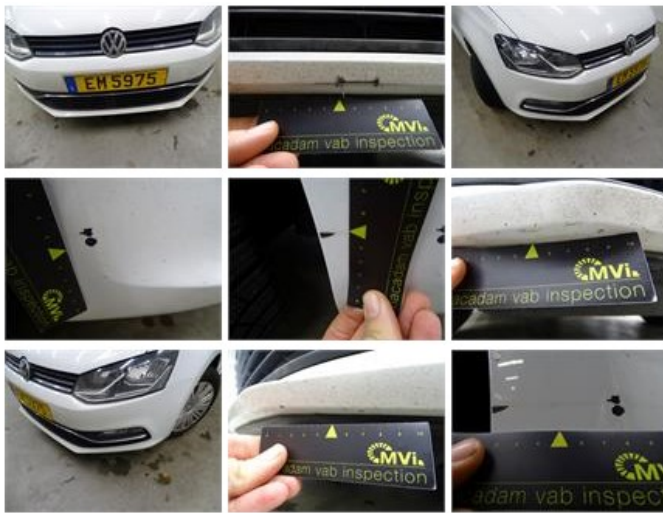
Total cost ex VAT	338,88
Bonnet, Stone chip(s), Acceptable	0,00
<i>No pictures to display</i>	
Bumper F, Scratch(es), LI - Repair and paint (complete)	169,44

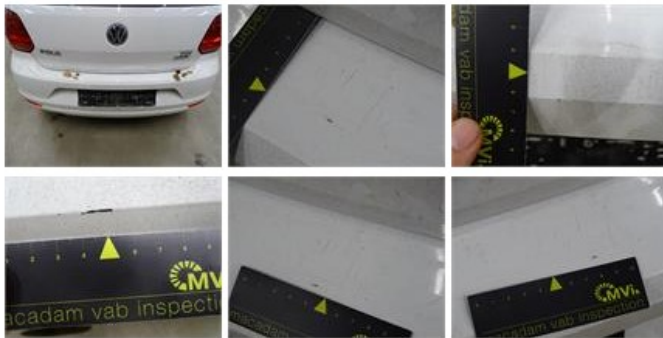
Wing R R, Scratch(es), Acceptable	0,00
<i>No pictures to display</i>	
Trunk lid covering R, Scratch(es), Acceptable	0,00
<i>No pictures to display</i>	
Sill outer L, Scratch(es), Acceptable	0,00
<i>No pictures to display</i>	
Door R R, Scratch(es), Acceptable	0,00
<i>No pictures to display</i>	
Bumper R, Scratch(es), LI - Repair and paint (complete)	169,44
