BMW 5 BERLINE: 1KHR964

Limited Technical Inspection

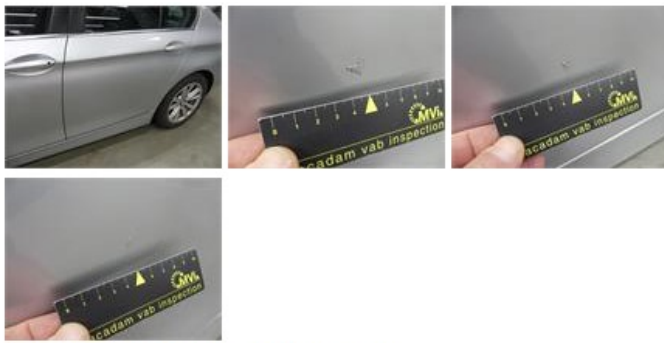
Door R L, Bad repair, LI - Repair and paint (complete)	382,02
--	---------------

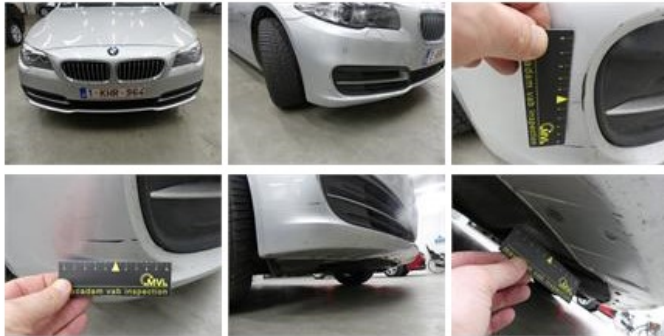
Bumper R, Dent(s) and scratch(es), Acceptable	0,00
<i>No pictures to display</i>	
Bumper F, Scratch(es), LI - Repair and paint (complete)	254,16
