LU Mercedes glc: TY8502			
Vinnumber:	WDC2539091F201073	Versionname:	2.1 GLC 250 D 4MATIC AUTO
First Registrationdate:	5/12/2016	Fiscalpower:	
Expertise Mileage:	78300	Power Kw:	150
Bodytype:		Body color:	Grey
Gearbox:	Automatic	Paint type:	Metalic
Transmission:	4 Weel	Rims summer:	Aluminium
Fueltype:	Diesel	Oil level:	OK
Battery functioning:	Yes	Parking lot:	4710
Number of doors:	5		
Number of seats:	5		
Number head rests:	5		
Rims summer:	Aluminium		
Category:	Passenger Car		
Oil level:	OK

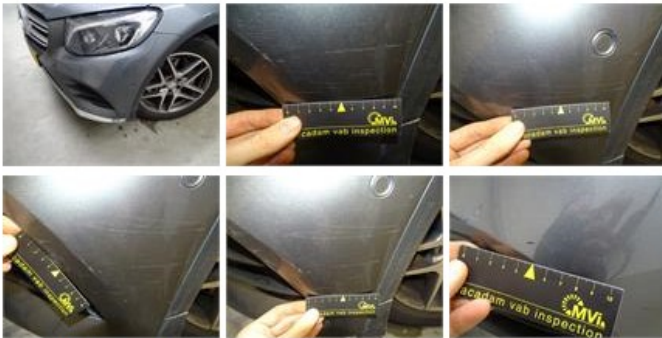
Bumper F, Scratch(es), LI - Repair and paint (complete) 254,16
