VOLVO XC60: 1REU930

Limited Technical Inspection

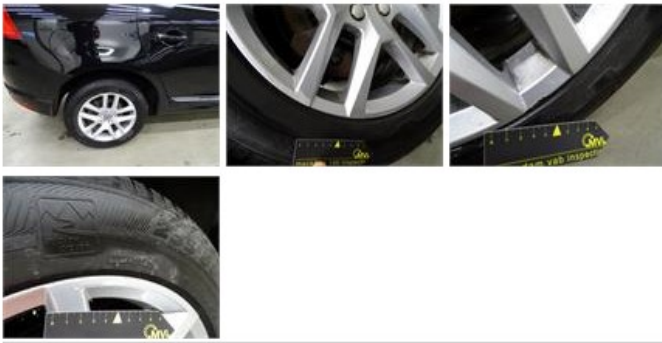
Repair kit	Yes	Compressor	Yes
Total cost ex VAT			349,16
Door R L, Scratch(es), Acceptable			0,00
<i>No pictures to display</i>			
Door R R, Scratch(es), Acceptable			0,00
<i>No pictures to display</i>			
Alloy rim R R, Scratch(es), LI - Repair and paint (complete)			95,00
