**LU Volkswagen Golf: VK7620**

**Limited Technical Inspection**

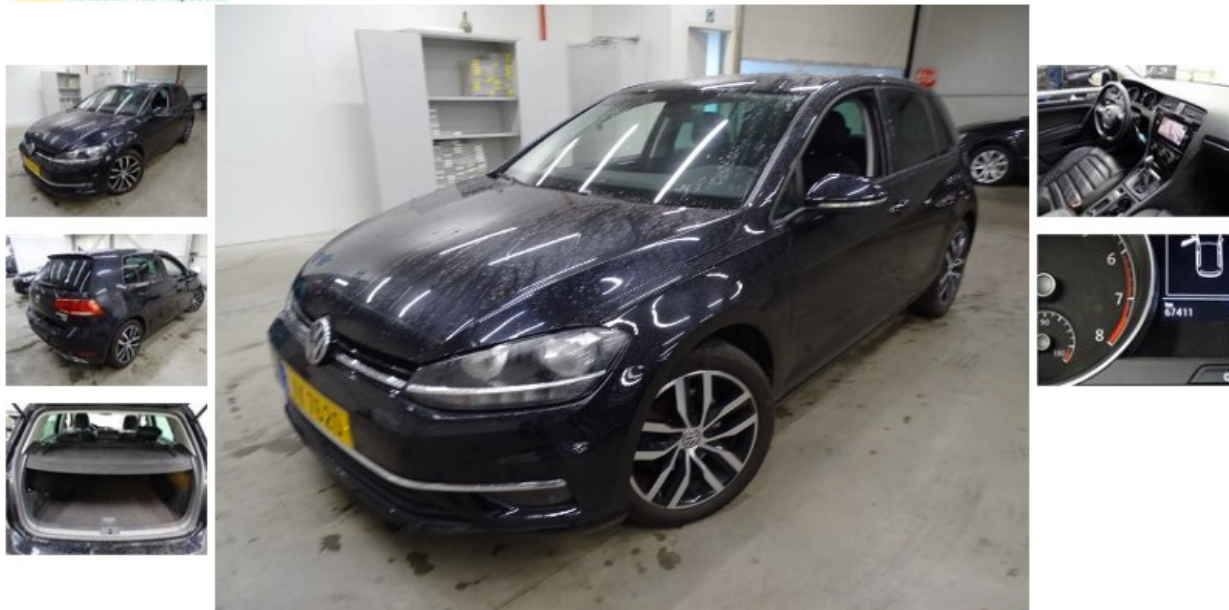
Vinnumber:	<b>WVWZZZAUZJP038879</b>	Versionname:	<b>1.5 TSI 110kW Highline DSG</b>
First Registrationdate:	<b>12/10/2017</b>	Fiscalpower:	
Expertise Mileage:	<b>67411</b>	Power Kw:	<b>110</b>
Bodytype:		Body color:	<b>Black</b>
Gearbox:	<b>Automatic</b>	Paint type:	<b>Metallic</b>
Transmission:	<b>Front</b>	Rims summer:	<b>Aluminium</b>
Fueltype:	<b>Petrol</b>	Oil level:	<b>OK</b>
Battery functioning:	<b>Yes</b>	Parking lot:	<b>2813</b>
Number of doors:	<b>5</b>		
Number of seats:	<b>5</b>		
Number head rests:	<b>5</b>		
Rims summer:	<b>Aluminium</b>		
Category:	<b>Passenger Car</b>		
Oil level:	<b>OK</b>		
Registration Certificate Car (BE):	<b>Yes</b>
