AUDI A4: 1JGK235

Vinnumber:	WAUZZZ8K5FA075218	Versionname:	A4 AVANT Ultra 136PK
First Registrationdate:	11/12/2014	Fiscalpower:	
Expertise Mileage:	131386	Power Kw:	100
Bodytype:		Body color:	Grey
Gearbox:	MAN 6 VIT	Paint type:	Metalic
Transmission:	Front	Rims summer:	Aluminium
Fueltype:	Diesel	Oil level:	OK
Maintenance:	18600	Parking lot:	2715
Maintenance:	3 DAGEN		
Maintenance:	OK		
Battery functioning:	Yes		
Number of doors:	5		
Number of seats:	5		
Number head rests:	5		
Rims summer:	Aluminium		
Category:	Passenger Car		
Oil level:	OK		
Registration Certificate Car (BE):	Yes

Limited Technical Inspection

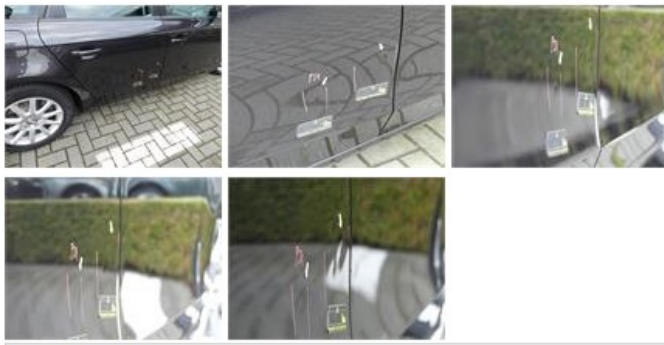
Total cost ex VAT	197,60
Door R R, Dent(s), PDR - Paintless dent repair	102,60

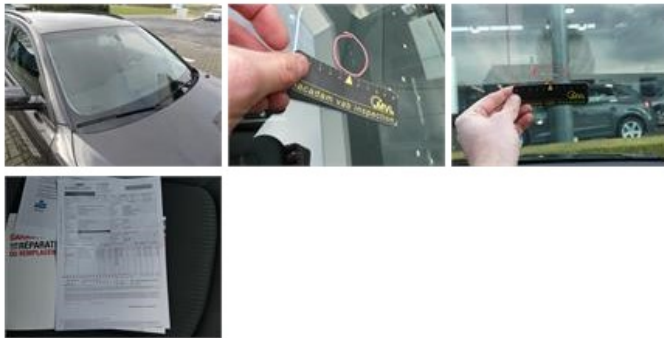
Door F R, Scratch(es), Acceptable	0,00
<i>No pictures to display</i>	
Outer backrest protection R, Scratch(es), Acceptable	0,00
<i>No pictures to display</i>	
Tires, Not original part, Acceptable	0,00
<i>No pictures to display</i>	
Door F L, Scratch(es), Acceptable	0,00
<i>No pictures to display</i>	
Rear window, Scratch(es), Acceptable	0,00
<i>No pictures to display</i>	
Alloy rim F L, Scratch(es), Acceptable	0,00
<i>No pictures to display</i>	
Wing R L, Scratch(es), Acceptable	0,00
<i>No pictures to display</i>	
Internal Boot Lining R, Scratch(es), Acceptable	0,00
<i>No pictures to display</i>	
Windscreen, Bad repair, E - Replace	0,00

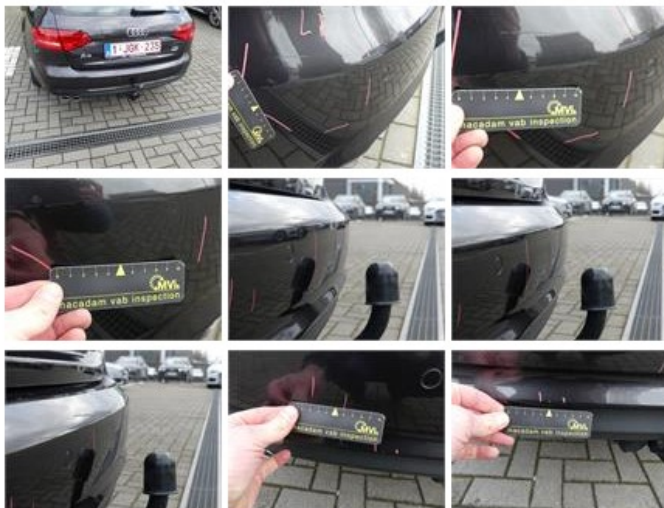
Bonnet, Stone chip(s), Acceptable	0,00
<i>No pictures to display</i>	
Bumper R, Dent(s) and scratch(es), Le - Replace and paint	0,00

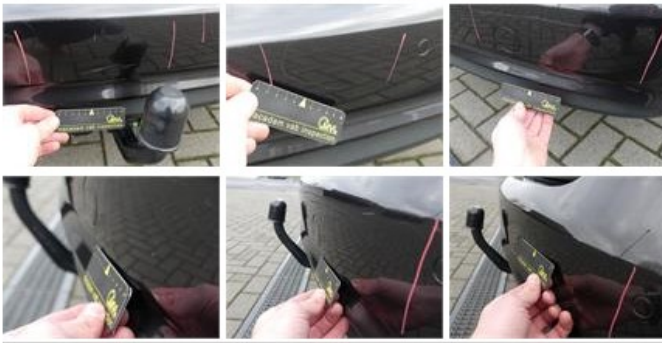
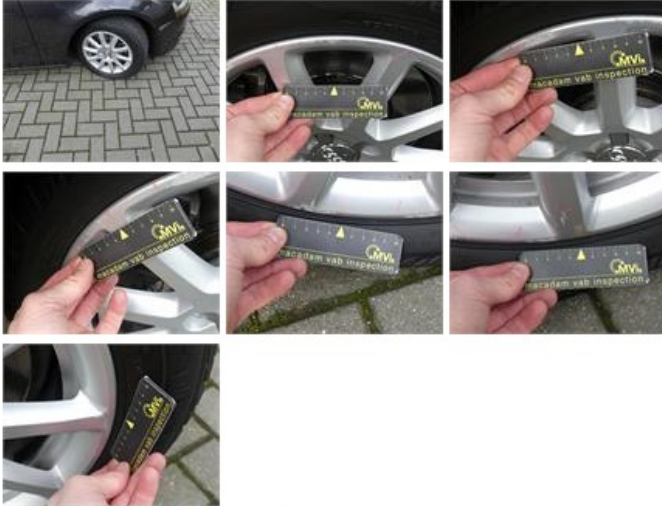
Alloy rim F R, Scratch(es), LI - Repair and paint (complete) 95,00
