BMW 5 BERLINE: 1JFS725

Limited Technical Inspection

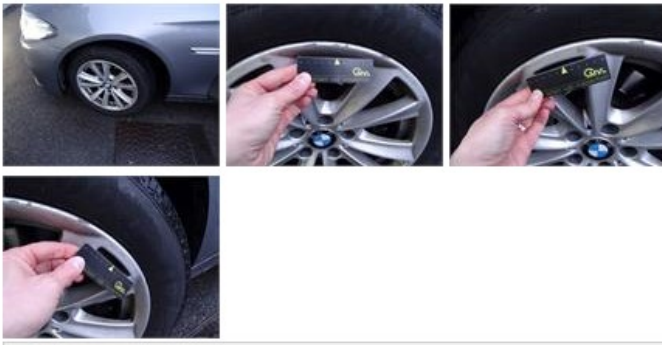
Alloy rim F L, Scratch(es), LI - Repair and paint (complete)	95,00
--------------------------------------------------------------	--------------
