RENAULT CLIO: 1LTB022

Limited Technical Inspection

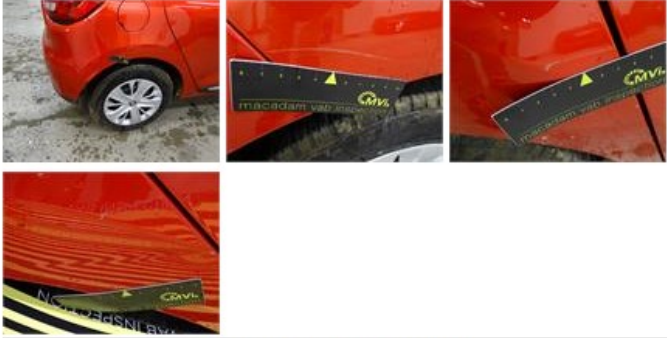
Door R L, Scratch(es), Acceptable	0,00
<i>No pictures to display</i>	
Wing R R, Dent(s) and scratch(es), LI - Repair and paint (complete)	246,56
