SKODA OCTAVIA COMBI: 1KPZ719

Limited Technical Inspection

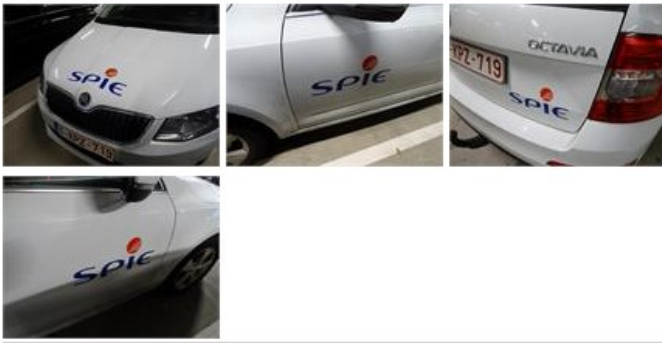
Total cost ex VAT	361,80
Seat cover F L, Tear, Acceptable	0,00
<i>No pictures to display</i>	
Bodywork, Not original part, Remove lettering	0,00
