VW TOURAN: 1LVZ689

Limited Technical Inspection

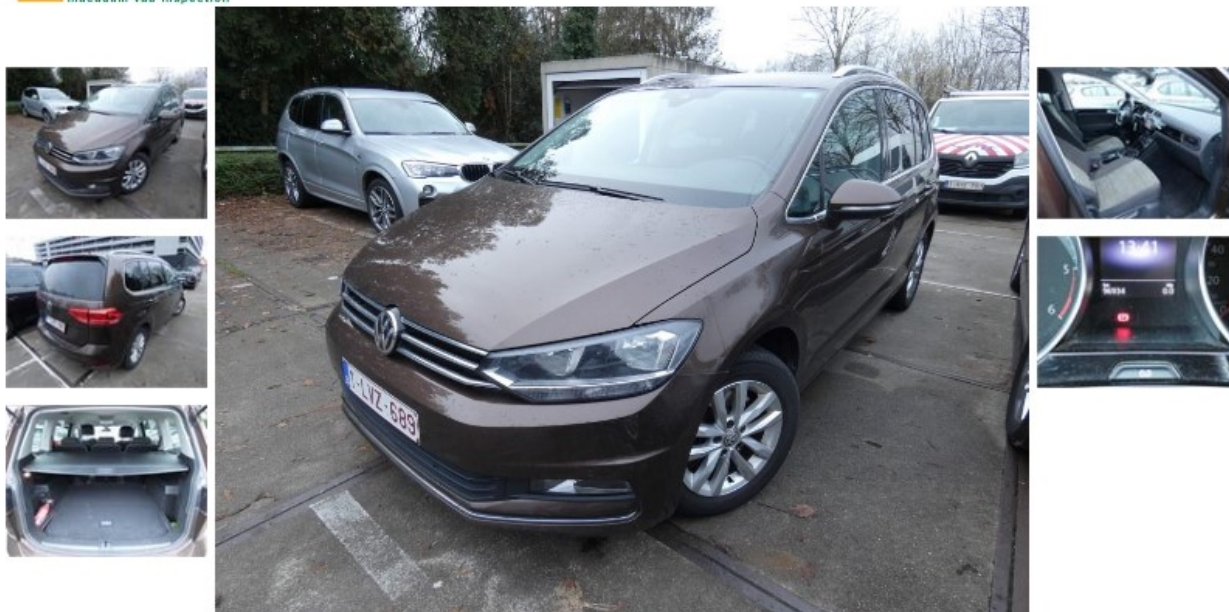
Vinnumber:	WVGZZZ1TZGW531712	Versionname:	
First Registrationdate:	21/12/2015	Fiscalpower:	81
Expertise Mileage:	96934	Power Kw:	
Bodytype:		Body color:	Dark Brown
Gearbox:	MAN 6 VIT	Paint type:	Metalic
Transmission:	Front	Rims summer:	Aluminium
Fueltype:	Diesel	Oil level:	OK
Maintenance:	OK	Parking lot:	PARKING GARAGE
Battery functioning:	Yes		
Number of doors:	5		
Number of seats:	5		
Number head rests:	5		
Rims summer:	Aluminium		
Category:	Passenger Car		
Oil level:	OK		
Registration Certificate Car (BE):	Yes
