OPEL Insignia: 1CMG576

Limited Technical Inspection

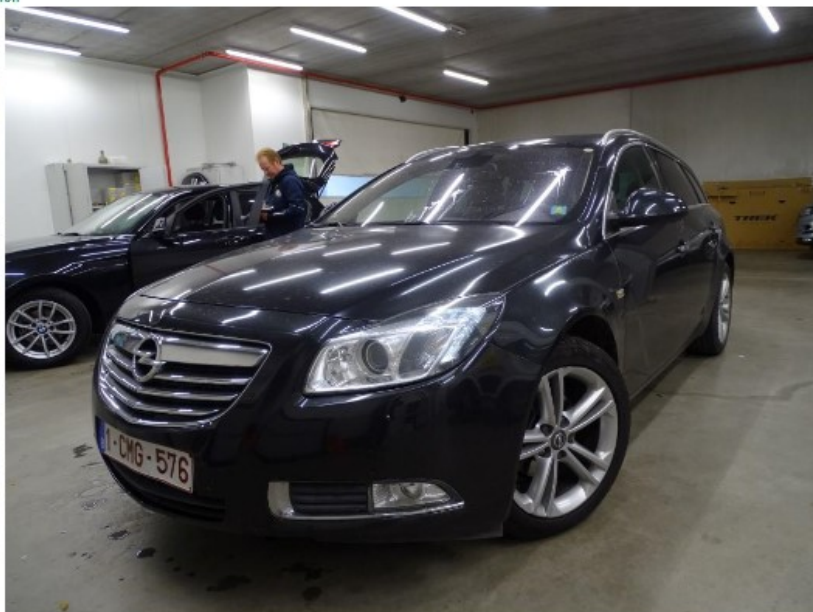
Vinnumber:	W0LGT8ELXC1044317	Versionname:	INSIGNIA BRE ecofl.Cosmo S/S DPF 130PK
First Registrationdate:	3/01/2012	Fiscalpower:	
Expertise Mileage:	155007	Power Kw:	96
Bodytype:		Body color:	Grey
Gearbox:	MAN 6 VIT	Paint type:	Metalic
Transmission:	Front	Rims summer:	Aluminium
Fueltype:	Diesel	Oil level:	OK
Maintenance:	OK	Parking lot:	3502
Battery functioning:	Yes		
Number of doors:	5		
Number of seats:	5		
Number head rests:	5		
Rims summer:	Aluminium		
Category:	Passenger Car		
Oil level:	OK
