OPEL ASTRA SPORTS TOURER: 1KKA527

Limited Technical Inspection

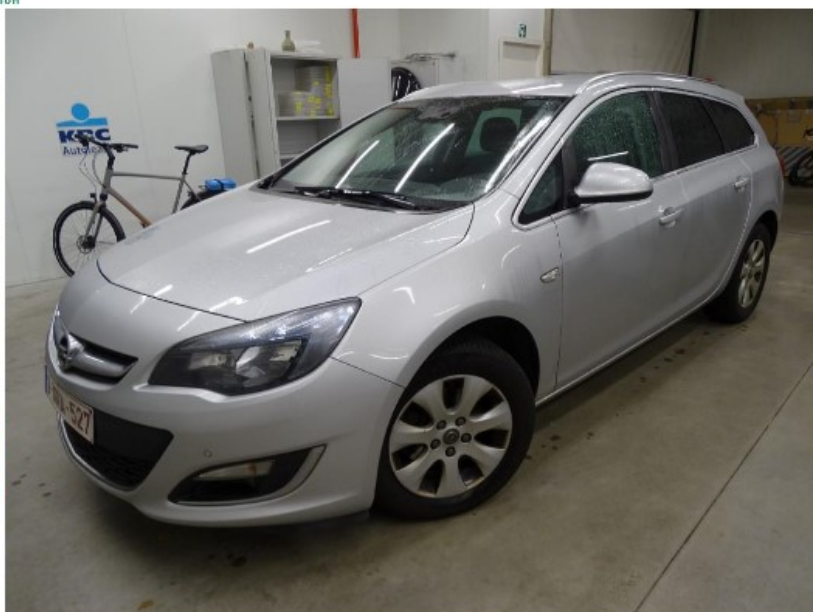
Vinnumber:	WOLPE8E62F8053058	Versionname:	1.6 CDTI 81KW ECOFLEX S/S ULTIMATE PLUS
First Registrationdate:	18/05/2015	Fiscalpower:	
Expertise Mileage:	105744	Power Kw:	81
Bodytype:		Body color:	Silver
Gearbox:	MAN 6 VIT	Paint type:	Metallic
Transmission:	Front	Rims summer:	Aluminium
Fueltype:	Diesel	Oil level:	OK
Battery functioning:	Yes	Parking lot:	3626
Number of doors:	5		
Number of seats:	5		
Number head rests:	5		
Rims summer:	Aluminium		
Category:	Passenger Car		
Oil level:	OK		
Registration Certificate Car (BE):	Yes
