**MERCEDES C: 1HZR630**

**Limited Technical Inspection**

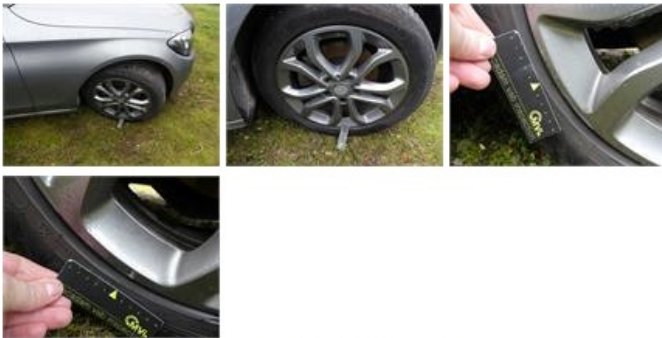
Windscreen, Stone chip(s), Acceptable	0,00
<i>No pictures to display</i>	
Alloy rim F L, Scratch(es), Acceptable	0,00
<i>No pictures to display</i>	
Door F R, Scratch(es), Acceptable	0,00
<i>No pictures to display</i>	
Wing R R, Dent(s) and scratch(es), Acceptable	0,00
<i>No pictures to display</i>	
Bonnet, Scratch(es), Acceptable	0,00
<i>No pictures to display</i>	
Alloy rim F R, Scratch(es), LI - Repair and paint (complete)	95,00
