VOLKSWAGEN TOURAN: 1N1N266

Vinnumber:	WVGZZZ1TZGW558098	Versionname:	1.6 TDI SCR 81KW BMT TRENDLINE
First Registrationdate:	4/03/2016	Fiscalpower:	
Expertise Mileage:	144811	Power Kw:	81
Bodytype:		Body color:	Grey
Gearbox:	MAN 6 VIT	Paint type:	Metalic
Transmission:	Front	Rims summer:	Steel
Fueltype:	Diesel	Oil level:	OK
Battery functioning:	Yes	Parking lot:	3329
Number of doors:	5		
Number of seats:	7		
Number head rests:	7		
Rims summer:	Steel		
Category:	Passenger Car		
Oil level:	OK		
Registration Certificate Car (BE):	Yes

Limited Technical Inspection

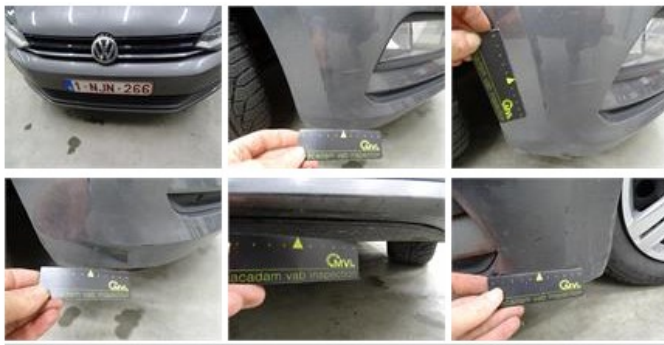
Total cost ex VAT	390,36
Wing R R, Dent(s), Acceptable	0,00
<i>No pictures to display</i>	
Bumper F, Scratch(es), LI - Repair and paint (complete)	211,80
