SKODA Octavia: 1HZR617

Limited Technical Inspection

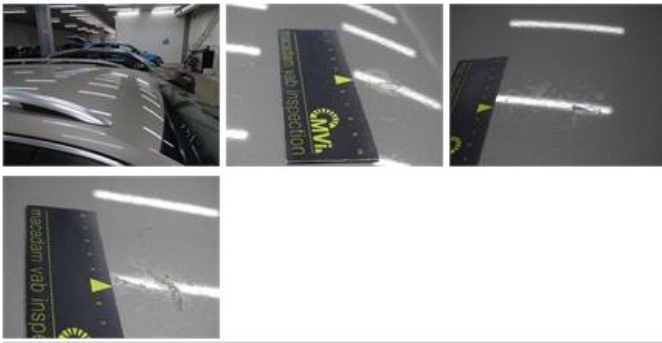
Total cost ex VAT	771,58
Bumper F, Scratch(es), Acceptable	0,00
<i>No pictures to display</i>	
Alloy rim R R, Scratch(es), Acceptable	0,00
<i>No pictures to display</i>	
Roof, Chemical polution, LI - Repair and paint (complete)	481,50

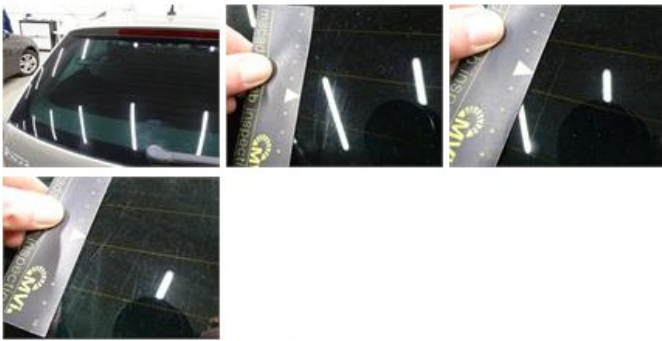
Rear window, Scratch(es), E - Replace 0,00
