## VOLVO XC60: 1LHY261

## Limited Technical Inspection

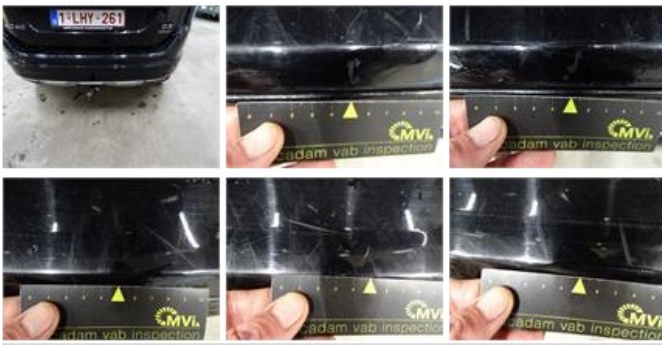
Total cost ex VAT	317,16
Wing R L, Scratch(es), Acceptable	0,00
<i>No pictures to display</i>	
Bumper R, Scratch(es), LI - Repair and paint (complete)	254,16
