FORD C-MAX: 1SAZ762

Limited Technical Inspection

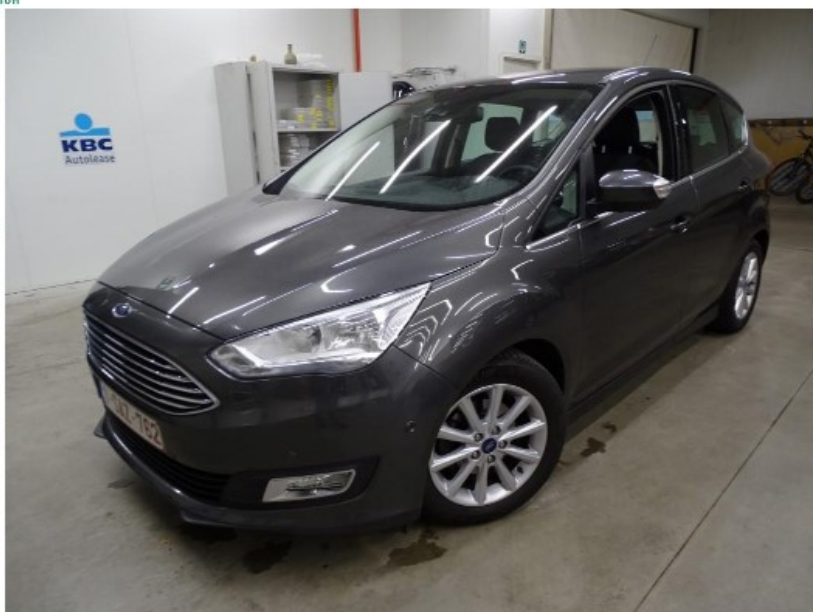
Vinnumber:	WF0VXXGCEVGD49774	Versionname:	1.0 92KW ECOBOOST S/S BUSINESS CLASS+
First Registrationdate:	29/03/2017	Fiscalpower:	
Expertise Mileage:	70918	Power Kw:	92
Bodytype:		Body color:	Grey
Gearbox:	MAN 6 VIT	Paint type:	Metalic
Transmission:	Front	Rims summer:	Aluminium
Fueltype:	Petrol	Oil level:	OK
Battery functioning:	Yes	Parking lot:	1726
Number of doors:	5		
Number of seats:	5		
Number head rests:	5		
Rims summer:	Aluminium		
Category:	Passenger Car		
Oil level:	OK		
Registration Certificate Car (BE):	Yes
