TOYOTA Auris: 1FWF225

Limited Technical Inspection

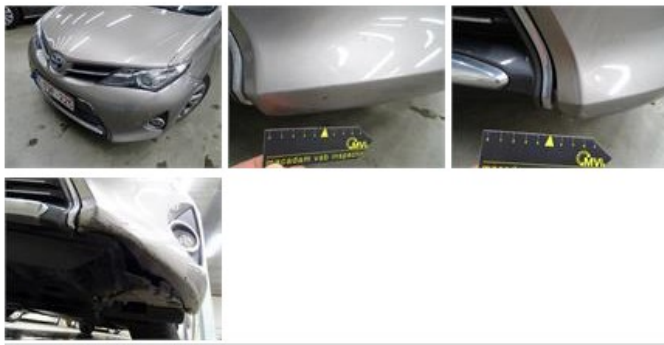
Total cost ex VAT	1371,80
Roof, Dent(s), Acceptable	0,00
<i>No pictures to display</i>	
Bumper F, Deformed / Strained, LI - Repair and paint (complete)	259,80

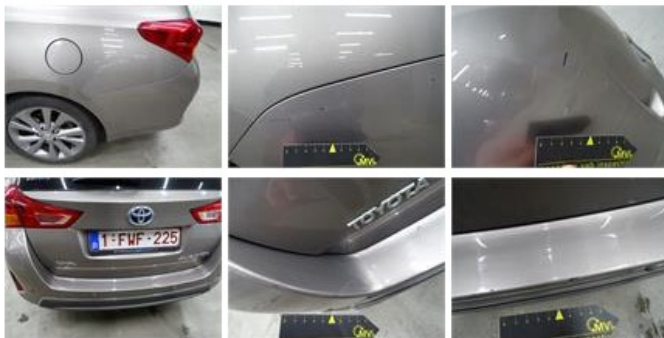
Bumper R, Scratch(es), LI - Repair and paint (complete)

259,80
