FORD MONDEO: 1NEP510

Limited Technical Inspection

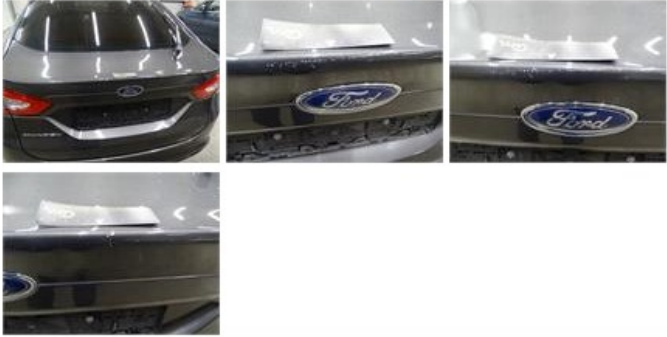
<i>No pictures to display</i>	
Bumper F, Scratch(es), Acceptable	0,00
<i>No pictures to display</i>	
Wing R L, Scratch(es), Acceptable	0,00
<i>No pictures to display</i>	
Door R R, Scratch(es), Acceptable	0,00
<i>No pictures to display</i>	
Door F R, Scratch(es), Acceptable	0,00
<i>No pictures to display</i>	
Tailgate, Scratch(es), LI - Repair and paint (complete)	301,68
