BMW 3 BERLINE: 1NDN774

Limited Technical Inspection

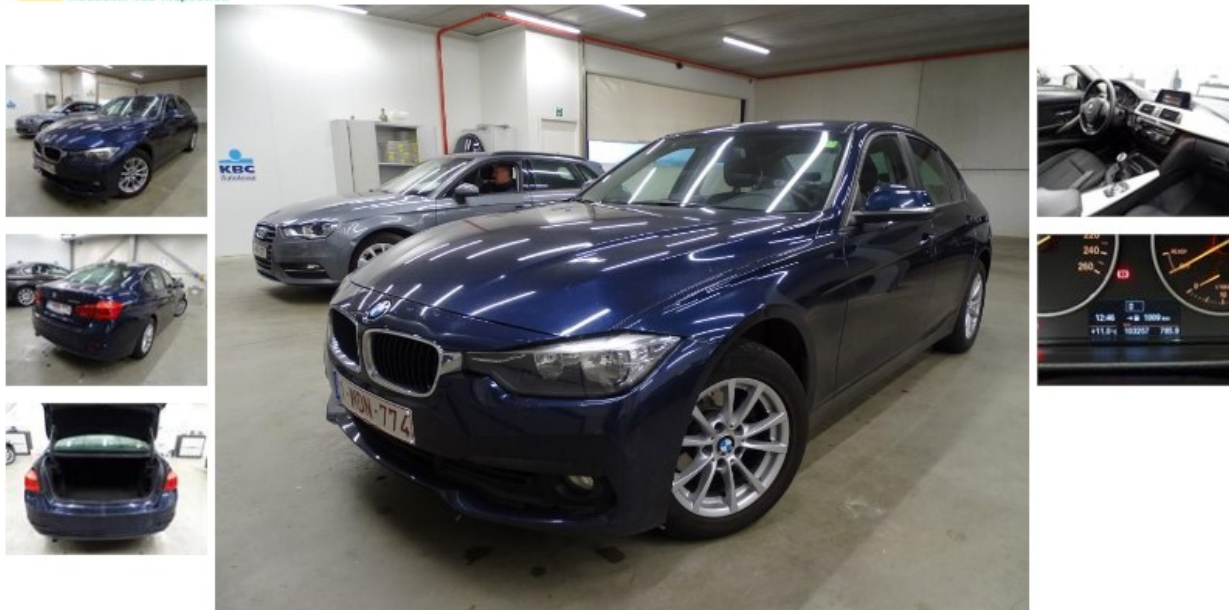
Vinnumber:	WBA8C31060K706109	Versionname:	2.0 318D (100KW) BERLINE
First Registrationdate:	28/01/2016	Fiscalpower:	
Expertise Mileage:	103257	Power Kw:	100
Bodytype:	Berline	Body color:	Dark Blue
Gearbox:	MAN 6 VIT	Paint type:	Metalic
Transmission:	Back	Rims summer:	Aluminium
Fueltype:	Diesel	Oil level:	OK
Maintenance:	OK	Parking lot:	2225
Battery functioning:	Yes		
Number of doors:	4		
Number of seats:	5		
Number head rests:	5		
Rims summer:	Aluminium		
Category:	Passenger Car		
Oil level:	OK		
Registration Certificate Car (BE):	Yes
