OPEL COMBO: 1RDV615

Limited Technical Inspection

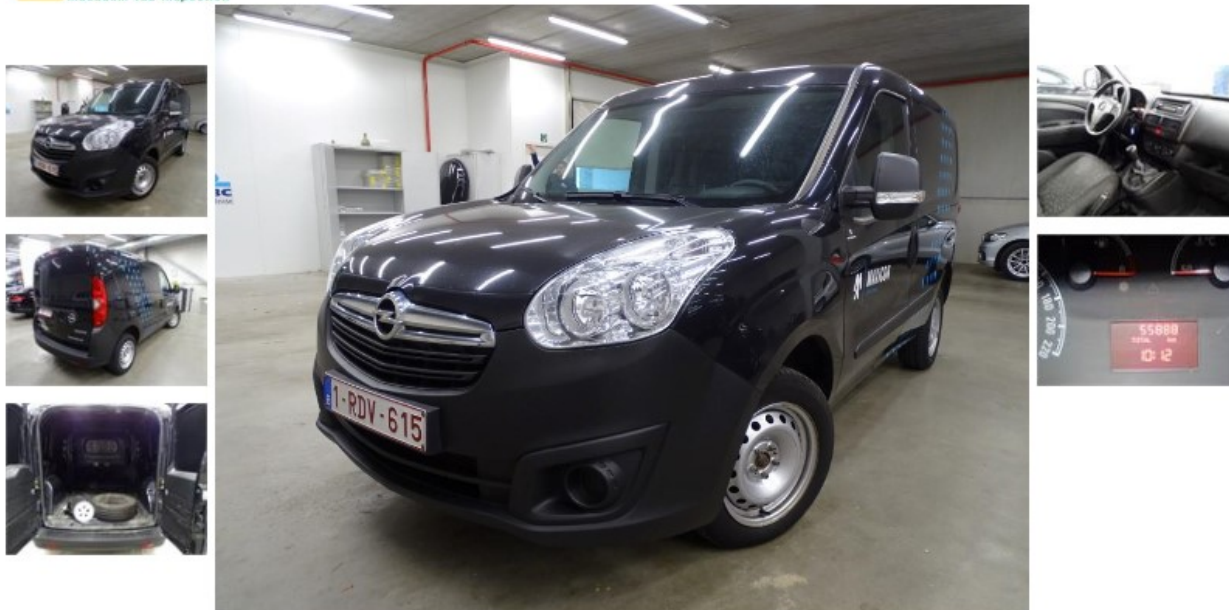
Vinnumber:	W0L6ZZU1AH9606350	Versionname:	1.3 CDTi 70KW 2.0T L1H1
First Registrationdate:	25/11/2016	Fiscalpower:	
Expertise Mileage:	55888	Power Kw:	70
Bodytype:		Body color:	Black
Gearbox:	MAN 5 VIT	Paint type:	Metalic
Transmission:	Front	Rims summer:	Steel
Fueltype:	Diesel	Oil level:	OK
Maintenance:	OK	Parking lot:	4731
Battery functioning:	Yes		
Number of doors:	4		
Number of seats:	2		
Number head rests:	2		
Rims summer:	Steel		
Category:	Light Commercial Vehicle		
Oil level:	OK		
Registration Certificate Car (BE):	Yes
