**VOLKSWAGEN GOLF VII: 1LDY152**

**Limited Technical Inspection**

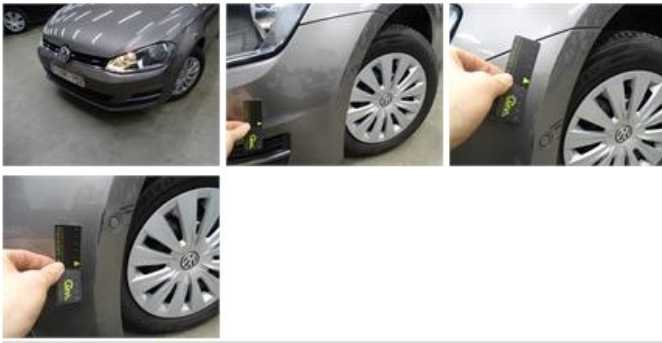
Total cost ex VAT	693,30
Bumper F, Scratch(es), LI - Repair and paint (complete)	211,80

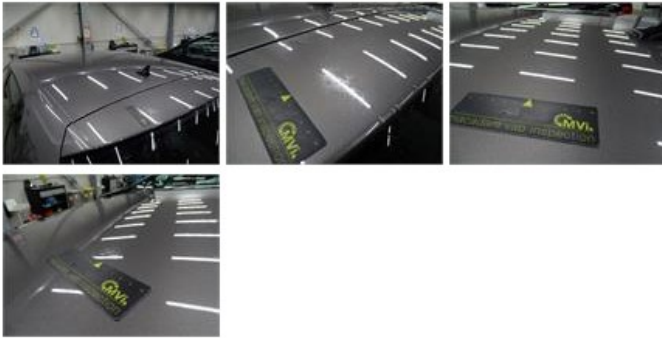
Rearview mirror housing R, Scratch(es), Acceptable	0,00
<i>No pictures to display</i>	
Wheel cover F R, Scratch(es), Acceptable	0,00
<i>No pictures to display</i>	
Bonnet, Scratch(es), Acceptable	0,00
<i>No pictures to display</i>	
Roof, Chemical pollution, LI - Repair and paint (complete)	481,50
