AUDI A5 SPORTBACK: 1LNB517

Limited Technical Inspection

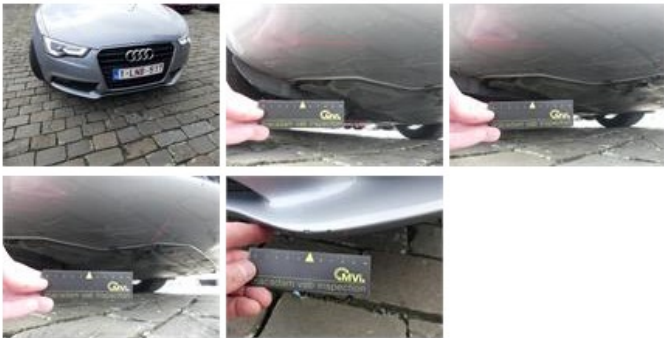
<i>No pictures to display</i>		
Wing R L, Repaired, Acceptable		0,00
<i>No pictures to display</i>		
Windscreen, Stone chip(s), Acceptable		0,00
<i>No pictures to display</i>		
Rear bulkhead lining, Scratch(es), Acceptable		0,00
<i>No pictures to display</i>		
Bumper F, Scratch(es), It - Spot repair		115,56
