BMW SERIE 1 HATCH: 1NAY765

Limited Technical Inspection

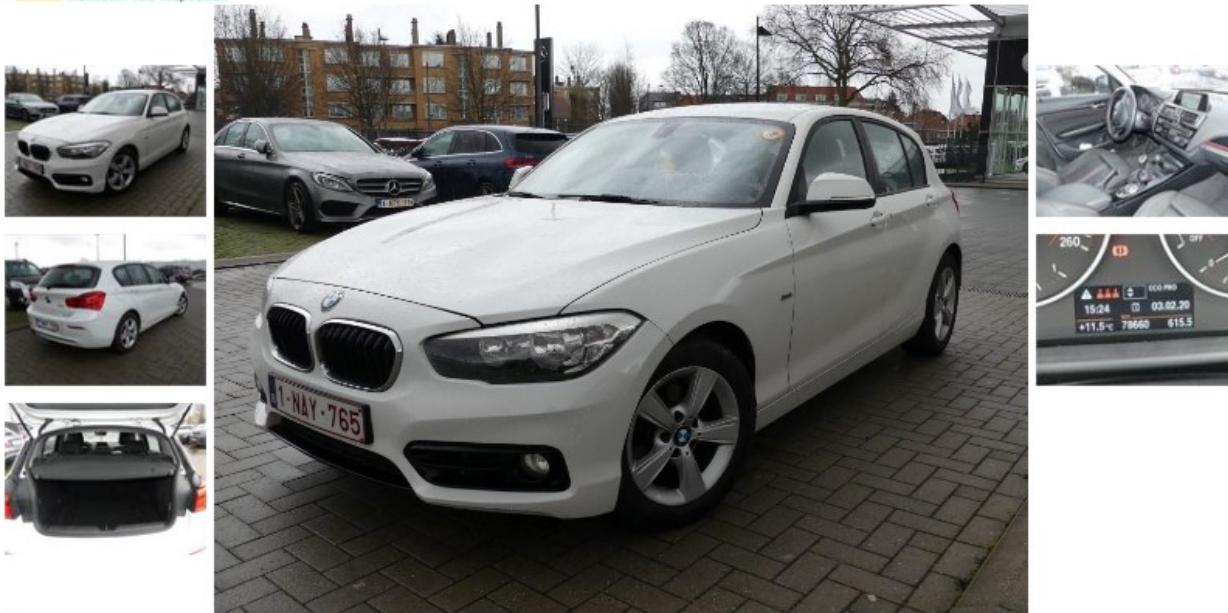
Vinnumber:	WBA1V910405D72534	Versionname:	116D EFFICIENTDYNAMICS EDIT
First Registrationdate:	7/01/2016	Fiscalpower:	
Expertise Mileage:	78660	Power Kw:	85
Bodytype:		Body color:	White
Gearbox:	MAN 6 VIT	Paint type:	Metalic
Transmission:	Back	Rims summer:	Aluminium
Fueltype:	Diesel	Oil level:	OK
Maintenance:	IN 5000 KM	Parking lot:	1526
Maintenance:	OK		
Battery functioning:	Yes		
Number of doors:	5		
Number of seats:	5		
Number head rests:	5		
Rims summer:	Aluminium		
Category:	Passenger Car		
Oil level:	OK		
Registration Certificate Car (BE):	Yes
