BMW 5 BERLINE: 1PED892

Limited Technical Inspection

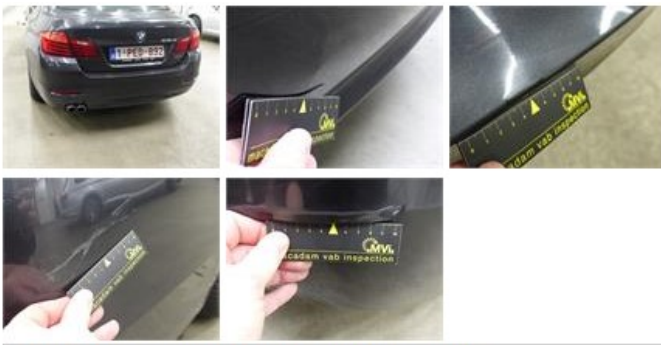
Repair kit	Yes	Compressor	Yes
Total cost ex VAT			484,16
Bumper R, Dent(s) and scratch(es), LI - Repair and paint (complete)			326,16

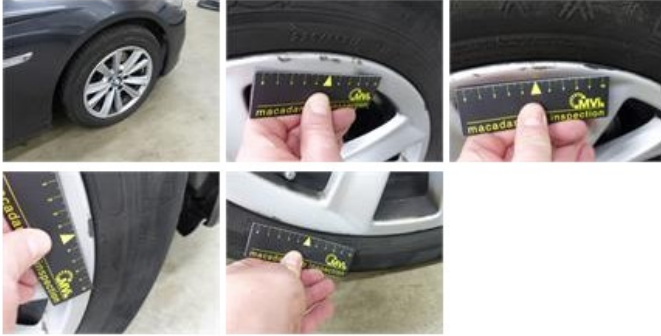
Alloy rim F R, Scratch(es), LI - Repair and paint (complete) 95,00
