CITROEN C3: 1HVS888

Limited Technical Inspection

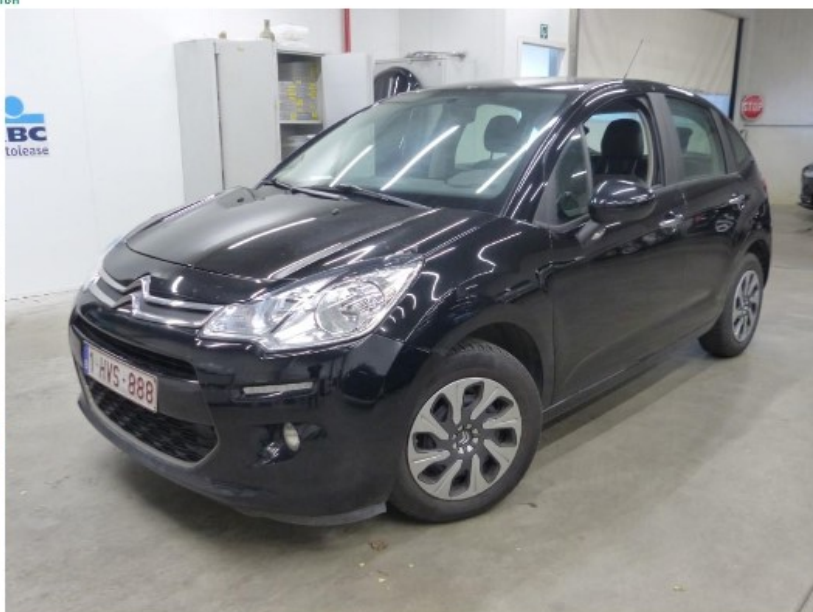
Vinnumber:	VF75C8HR4EW651989	Versionname:	C3 BER Business (Fleet) 68PK
First Registrationdate:	15/10/2014	Fiscalpower:	
Expertise Mileage:	129179	Power Kw:	50
Bodytype:		Body color:	Black
Gearbox:	MAN 5 VIT	Paint type:	Metalic
Transmission:	Front	Rims summer:	Steel
Fueltype:	Diesel	Oil level:	OK
Maintenance:	OK	Parking lot:	2204
Maintenance:	SERVICE IN 12300KM		
Battery functioning:	Yes		
Number of doors:	5		
Number of seats:	5		
Number head rests:	5		
Rims summer:	Steel		
Category:	Passenger Car		
Oil level:	OK		
Registration Certificate Car (BE):	Yes
