LAND ROVER DISCOVERY SPORT: 1PDF628

Limited Technical Inspection

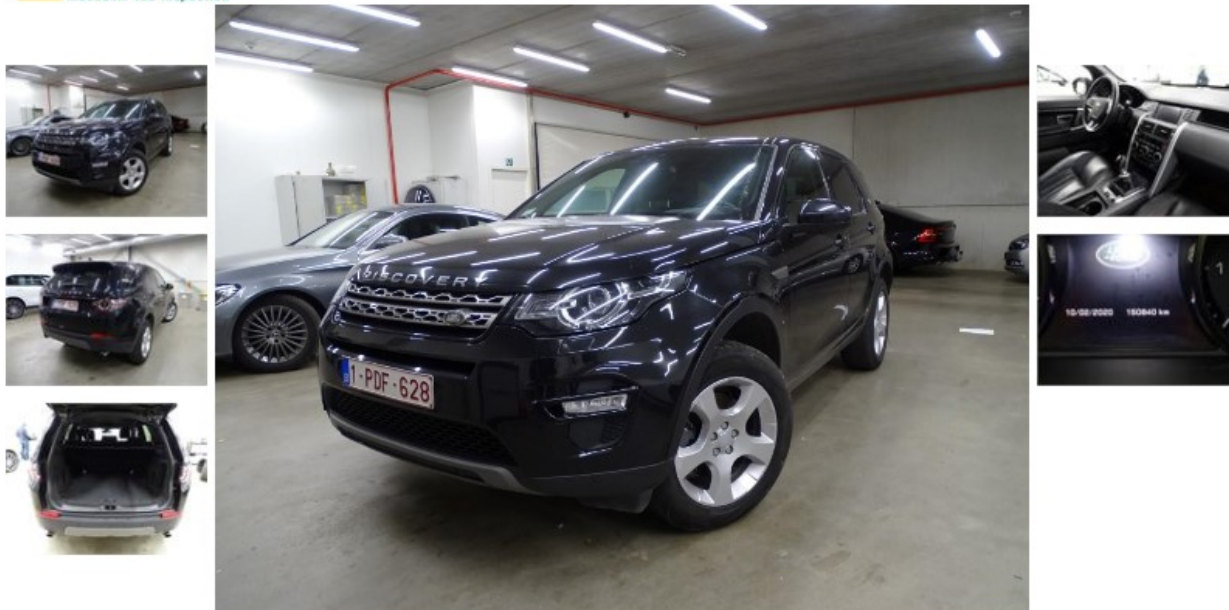
Vinnumber:	SALCB2DN8GH615635	Versionname:	2.0 ED4 110KW SE 2WD
First Registrationdate:	9/06/2016	Fiscalpower:	
Expertise Mileage:	150840	Power Kw:	110
Bodytype:		Body color:	Black
Gearbox:	MAN 6 VIT	Paint type:	Metalic
Transmission:	Front	Rims summer:	Aluminium
Fueltype:	Diesel	Oil level:	OK
Maintenance:	OK	Parking lot:	2531
Battery functioning:	Yes		
Number of doors:	5		
Number of seats:	5		
Number head rests:	5		
Rims summer:	Aluminium		
Category:	Passenger Car		
Oil level:	OK		
Registration Certificate Car (BE):	Yes
