VOLKSWAGEN Polo: PA9097

Limited Technical Inspection

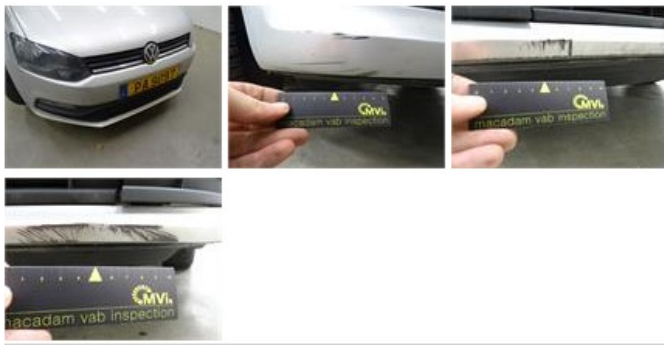
Total cost ex VAT	835,44
Wing F R, Dent(s), Acceptable	0,00
<i>No pictures to display</i>	
Rearview mirror housing R, Scratch(es), Acceptable	0,00
<i>No pictures to display</i>	
Bumper F, Scratch(es), LI - Repair and paint (complete)	169,44
