**VOLKSWAGEN GOLF SPORTSVAN: 1KPP742**

**Limited Technical Inspection**

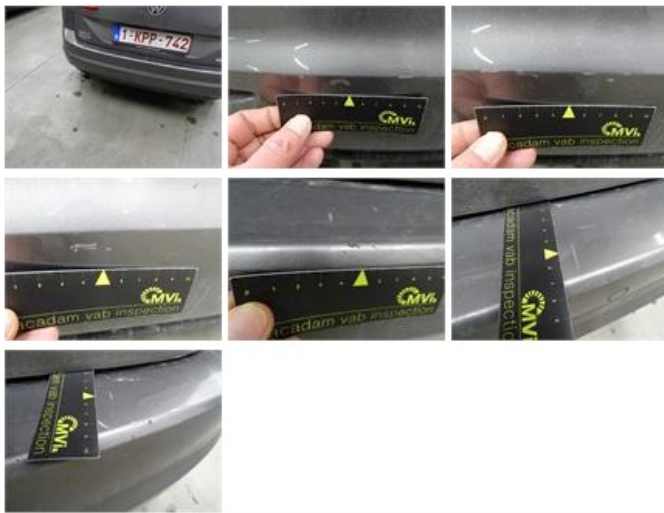
Total cost ex VAT	1021,88
Wing F L, Dent(s), Acceptable	0,00
<i>No pictures to display</i>	
Bumper R, Scratch(es), LI - Repair and paint (complete)	211,80

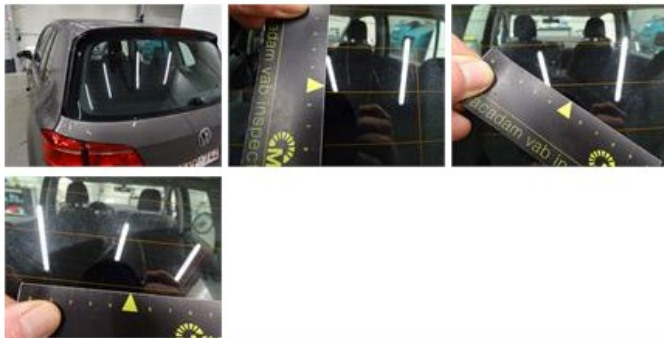
Rear window, Scratch(es), E - Replace 370,00
