VOLKSWAGEN Passat: 1HAB059

Limited Technical Inspection

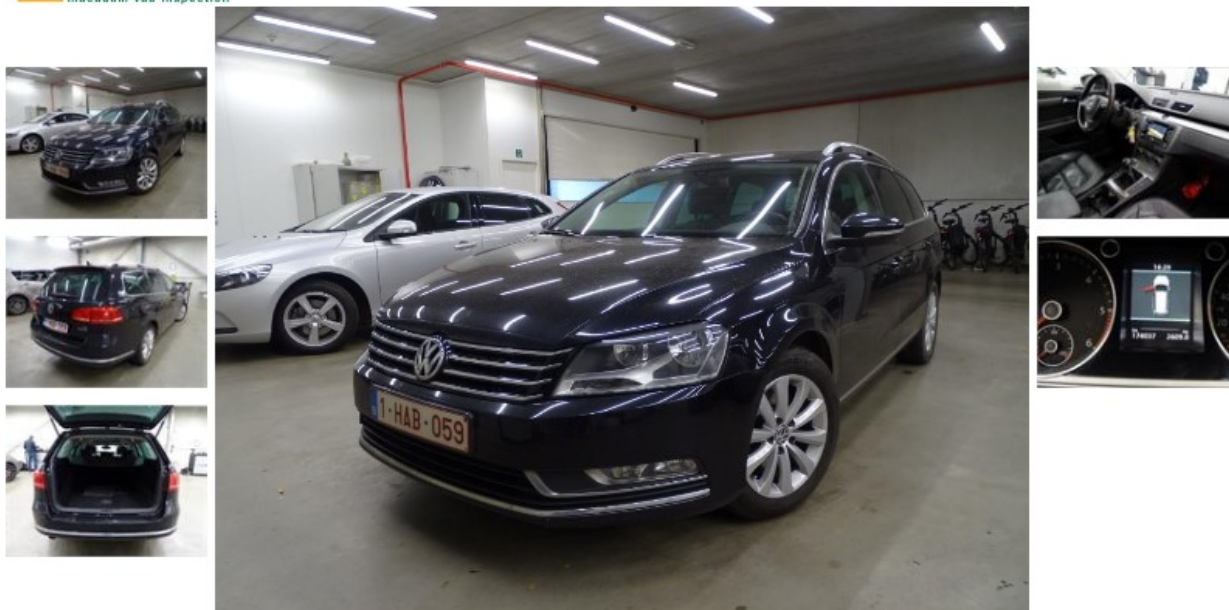
Vinnumber:	WVWZZZ3CZEE173365	Versionname:	PASSAT VAR Comfortline BMT 105PK
First Registrationdate:	2/06/2014	Fiscalpower:	
Expertise Mileage:	174037	Power Kw:	77
Bodytype:		Body color:	Black
Gearbox:	MAN 6 VIT	Paint type:	Metallic
Transmission:	Front	Rims summer:	Aluminium
Fueltype:	Diesel	Oil level:	OK
Maintenance:	OK	Parking lot:	1727
Battery functioning:	Yes		
Number of doors:	5		
Number of seats:	5		
Number head rests:	5		
Rims summer:	Aluminium		
Category:	Passenger Car		
Oil level:	OK		
Registration Certificate Car (BE):	Yes
