BMW 1 HATCH: 1NKR947

Limited Technical Inspection

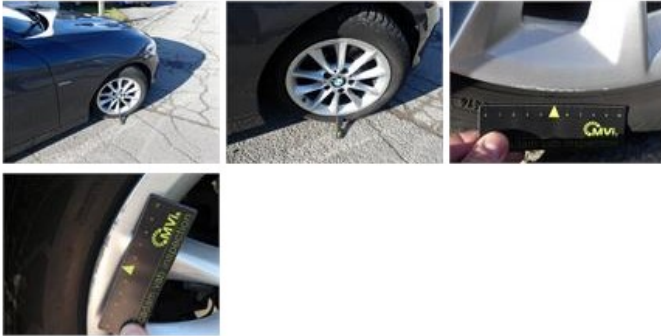
Door F R, Dent(s), Acceptable	0,00
<i>No pictures to display</i>	
Door R L, Dent(s), Acceptable	0,00
<i>No pictures to display</i>	
Wing R L, Dent(s), Acceptable	0,00
<i>No pictures to display</i>	
Alloy rim F R, Scratch(es), LI - Repair and paint (complete)	95,00
