AUDI Q5: 1JVX761			
Vinnumber:	WAUZZZ8R2FA103845	Versionname:	2.0 TDI 100KW
First Registrationdate:	10/03/2015	Fiscalpower:	
Expertise Mileage:	179465	Power Kw:	100
Bodytype:		Body color:	Blue
Gearbox:	MAN 6 VIT	Paint type:	Metallic
Transmission:	Front	Rims summer:	Aluminium
Fueltype:	Diesel	Oil level:	OK
Battery functioning:	Yes	Parking lot:	4822
Number of doors:	5		
Number of seats:	5		
Number head rests:	5		
Rims summer:	Aluminium		
Category:	Passenger Car		
Oil level:	OK		
Registration Certificate Car (BE):	Yes

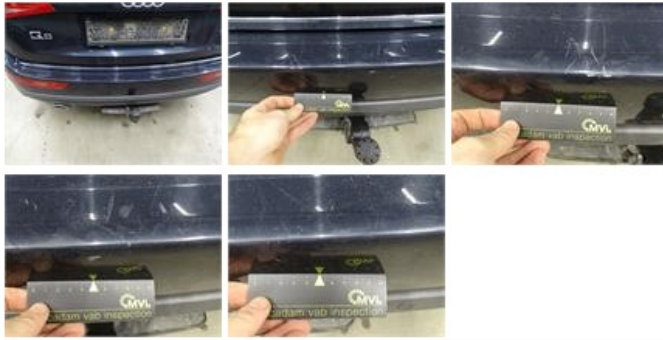
<i>No pictures to display</i>	
Alloy rim R R, Scratch(es), Acceptable	0,00
<i>No pictures to display</i>	
Bumper F, Scratch(es), Acceptable	0,00
<i>No pictures to display</i>	
Bumper R, Scratch(es), LI - Repair and paint (complete)	254,16
