<b>BMW 5: 1JAJ602</b>			
Vinnumber:	<b>WBA5E31010D786663</b>	Versionname:	<b>5 BER 518dA 136PK Aut.</b>
First Registrationdate:	<b>17/11/2014</b>	Fiscalpower:	
Expertise Mileage:	<b>136958</b>	Power Kw:	<b>100</b>
Bodytype:		Body color:	<b>Blue</b>
Gearbox:	<b>Automatic</b>	Paint type:	<b>Metalic</b>
Transmission:	<b>Back</b>	Rims summer:	<b>Aluminium</b>
Fueltype:	<b>Diesel</b>	Oil level:	<b>OK</b>
Battery functioning:	<b>Yes</b>	Parking lot:	<b>3405</b>
Number of doors:	<b>4</b>		
Number of seats:	<b>5</b>		
Number head rests:	<b>5</b>		
Rims summer:	<b>Aluminium</b>		
Category:	<b>Passenger Car</b>		
Oil level:	<b>OK</b>		
Registration Certificate Car (BE):	<b>Yes</b>

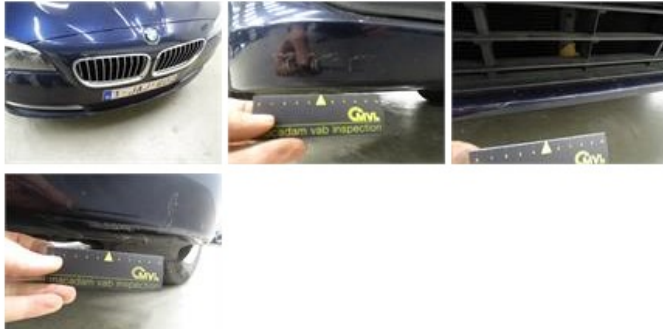
Bumper R, Scratch(es), Acceptable	0,00
<i>No pictures to display</i>	
Alloy rim F R, Scratch(es), Acceptable	0,00
<i>No pictures to display</i>	
Alloy rim F L, Scratch(es), Acceptable	0,00
<i>No pictures to display</i>	
Alloy rim R L, Scratch(es), Acceptable	0,00
<i>No pictures to display</i>	
Bumper F, Scratch(es), LI - Repair and paint (complete)	254,16
