OPEL COMBO: 1RDL015

Limited Technical Inspection

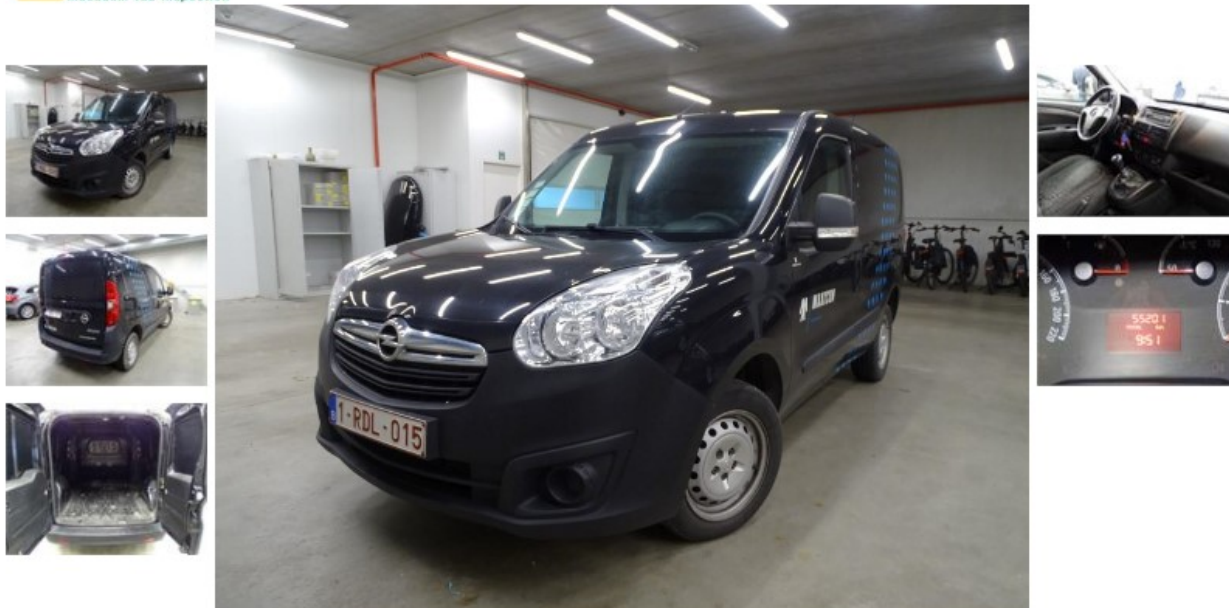
Vinnumber:	W0L6ZZU1AH9606341	Versionname:	1.3 CDTi 70KW 2.0T L1H1
First Registrationdate:	23/11/2016	Fiscalpower:	
Expertise Mileage:	55201	Power Kw:	70
Bodytype:		Body color:	Black
Gearbox:	MAN 5 VIT	Paint type:	Metalic
Transmission:	Front	Rims summer:	Steel
Fueltype:	Diesel	Oil level:	OK
Maintenance:	GEKLOP BIJ STUREN	Parking lot:	3826
Maintenance:	NOT OK		
Battery functioning:	Yes		
Number of doors:	4		
Number of seats:	2		
Number head rests:	2		
Rims summer:	Steel		
Category:	Light Commercial Vehicle		
Oil level:	OK		
Registration Certificate Car (BE):	Yes
