**OPEL INSIGNIA SPORTS TOURER: 1JNU447**

**Limited Technical Inspection**

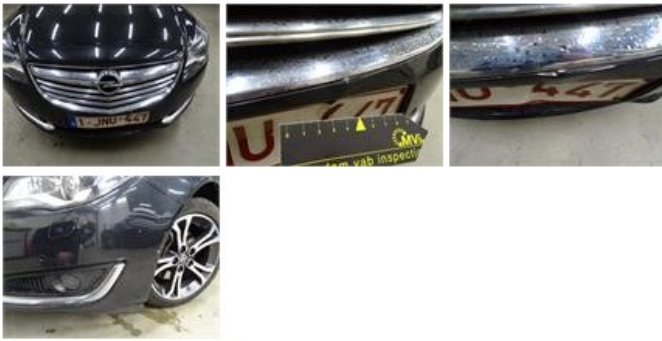
Emergency spare wheel	<b>Yes</b>	Jack	<b>Yes</b>
Total cost ex VAT			<b>1201,00</b>
Bumper F, Dent(s) and scratch(es), Le - Replace and paint			<b>735,00</b>
