BMW 3 BERLINE: 1NDZ675

Limited Technical Inspection

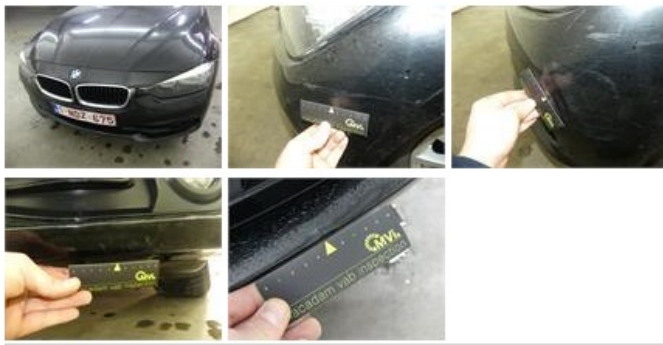
Bumper F, Dent(s) and scratch(es), LI - Repair and paint (complete)	211,80
---	---------------

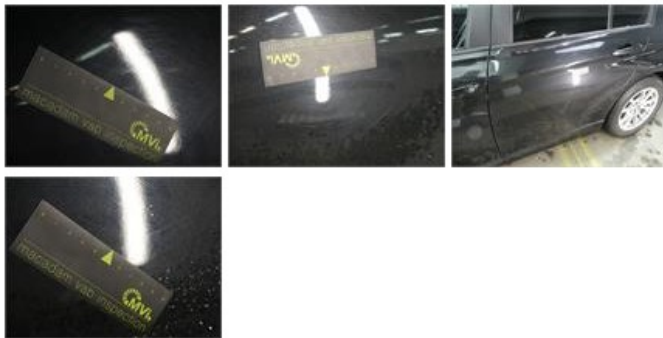
Tailgate, Dent(s), Acceptable	0,00
<i>No pictures to display</i>	
Roof pillar L, Dent(s), Acceptable	0,00
<i>No pictures to display</i>	
Door R L, Bad repair, LI - Repair and paint (complete)	318,35

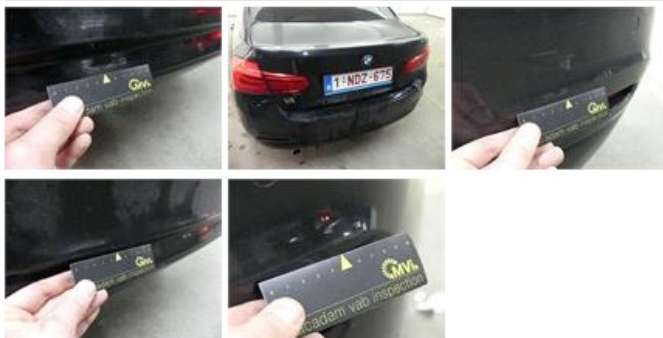
Bonnet, Scratch(es), Acceptable	0,00
<i>No pictures to display</i>	
Wing R L, Dent(s) and scratch(es), Acceptable	0,00
<i>No pictures to display</i>	
Bumper R, Dent(s) and scratch(es), LI - Repair and paint (complete)	211,80
