**TOYOTA GRAND PRIUS+: 1NJJ629**

**Limited Technical Inspection**

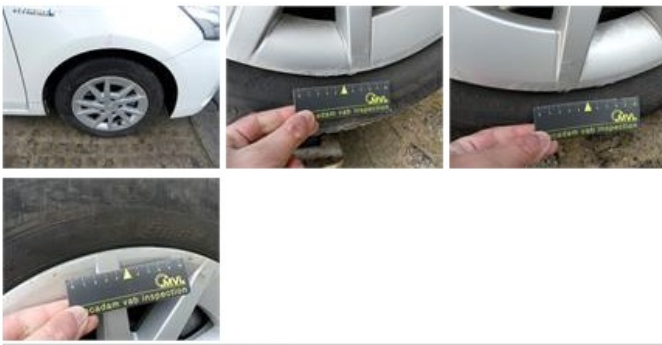
Emergency spare wheel	<b>Yes</b>	Jack	<b>Yes</b>
Total cost ex VAT			<b>308,76</b>
Wheel cover F R, Scratch(es), E - Replace			<b>30,00</b>

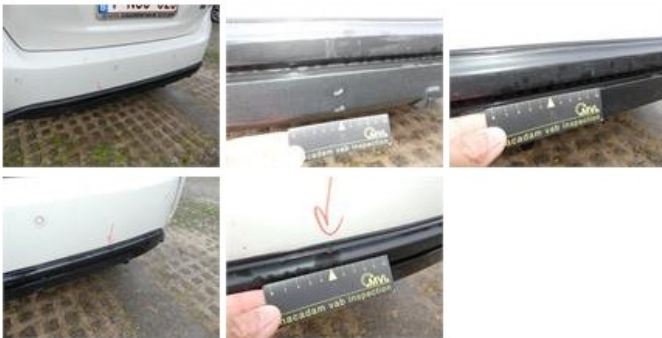
Spoiler R, Scratch(es), LI - Repair and paint (complete) 115,56
