**CITROEN JUMPER: 1CGG251**

**Limited Technical Inspection**

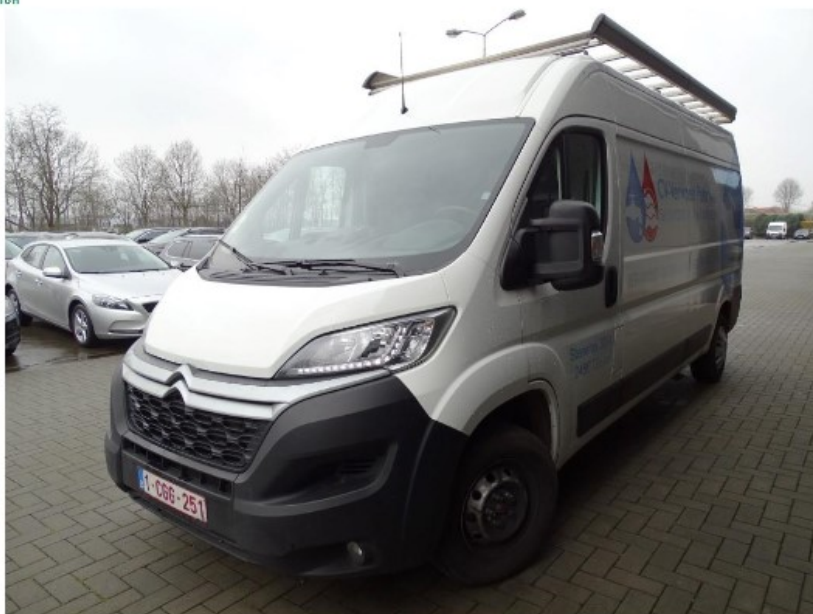
Vinnumber:	<b>VF7YC2MFC12H31686</b>	Versionname:	
First Registrationdate:	<b>19/09/2018</b>	Fiscalpower:	
Expertise Mileage:	<b>25694</b>	Power Kw:	<b>96</b>
Bodytype:		Body color:	<b>White</b>
Gearbox:	<b>MAN 6 VIT</b>	Paint type:	<b>Opaque</b>
Transmission:	<b>Front</b>	Rims summer:	<b>Steel</b>
Fueltype:	<b>Diesel</b>	Oil level:	<b>OK</b>
Battery functioning:	<b>Yes</b>	Parking lot:	<b>LCV31</b>
Number of doors:	<b>5</b>		
Number of seats:	<b>3</b>		
Number head rests:	<b>3</b>		
Rims summer:	<b>Steel</b>		
Category:	<b>Passenger Car</b>		
Oil level:	<b>OK</b>		
Registration Certificate Car (BE):	<b>Yes</b>
