VOLVO V60: 1V5F747			
Vinnumber:	YV1ZW72V1K2328563	Versionname:	D3 Momentum
First Registrationdate:	13/02/2019	Fiscalpower:	
Expertise Mileage:	84507	Power Kw:	110
Bodytype:		Body colour:	Grey
Gearbox:	MAN 6 VIT	Type of rims (mounted):	Aluminium
Transmission:		Parking lot:	2511
Fueltype:	Diesel		
Type of rims (mounted):	Aluminium		
Certificate of Conformity:	Yes		
Category:	Passenger Car		
Registration Certificate Car (BE):	Yes

Limited Technical Inspection

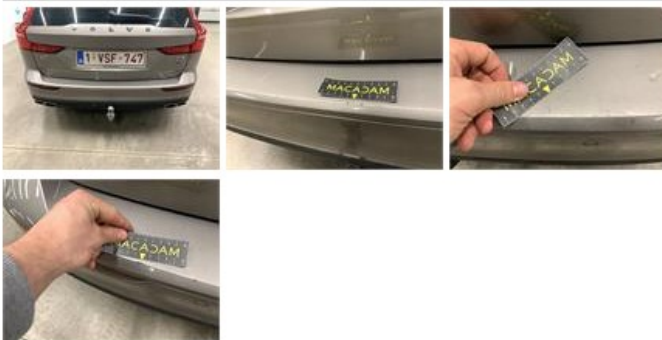
Tyre RR, Tear, Replace	171,56
-------------------------------	---------------

Door panel FR, Scratch(es), Acceptable	0,00
---	-------------

Bumper F, Scratch(es), Acceptable 0,00

Wing RR, Dent(s), Paintless dent repair 90,00

Bonnet, Chemical polution, Polish 0,00

Alloy rim FL, Scratch(es), Acceptable 0,00

Alloy rim RL, Scratch(es), Acceptable 0,00

Roof, Chemical polution, Cleaning 0,00

Bumper R, Scratch(es), Polish 0,00
