BMW 318d: 1HLC601

Limited Technical Inspection

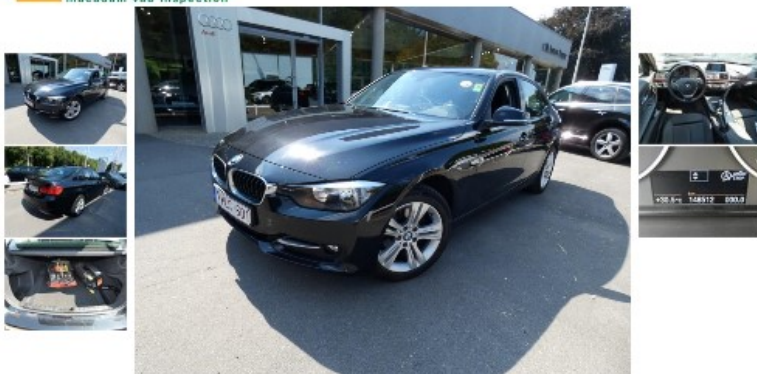
Vinnumber:	WBA3D11000P700000	Versionname:	BER 136PK 2014
First Registrationdate:	18/08/2014	Fiscalpower:	
Expertise Mileage:	148512	Power Kw:	100
Bodytype:		Body color:	Black
Gearbox:	MAN 6 VIT	Paint type:	Metalic
Transmission:	Back	Rims summer:	Aluminium
Fueltype:	Diesel	Oil level:	OK
Maintenance:	OK	Parking lot:	4728
Maintenance:	60.000 KM		
Maintenance:	1/05/2022		
Battery functioning:	Yes		
Number of doors:	4		
Number of seats:	5		
Number head rests:	5		
Rims summer:	Aluminium		
Category:	Passenger Car		
Oil level:	OK		
Registration Certificate Car (BE):	Yes
