BMW 5: 1DHD499

Limited Technical Inspection

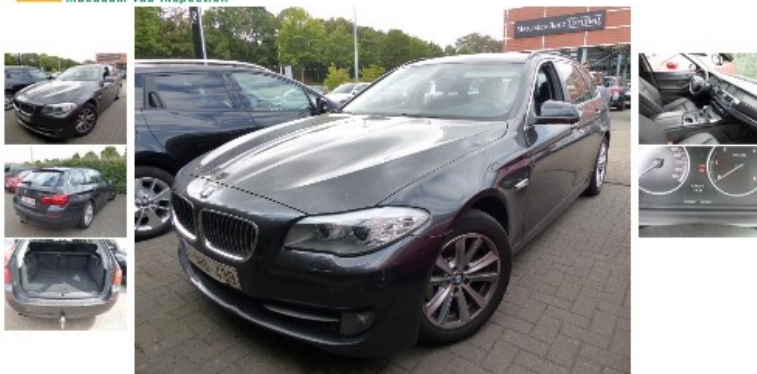
Vinnumber:	WBAMX11010C975636	Versionname:	5 TOURING 520d Start/Stop 163PK
First Registrationdate:	15/05/2012	Fiscalpower:	
Expertise Mileage:	141529	Power Kw:	120
Bodytype:	Break	Body color:	Black
Gearbox:	MAN 6 VIT	Paint type:	Metalic
Transmission:	Back	Rims summer:	Aluminium
Fueltype:	Diesel	Oil level:	OK
Battery functioning:	Yes	Parking lot:	3312
Number of doors:	5		
Number of seats:	5		
Number head rests:	5		
Rims summer:	Aluminium		
Category:	Passenger Car		
Oil level:	OK		
Registration Certificate Car (BE):	No
