SKODA Superb: 1HFG296

Limited Technical Inspection

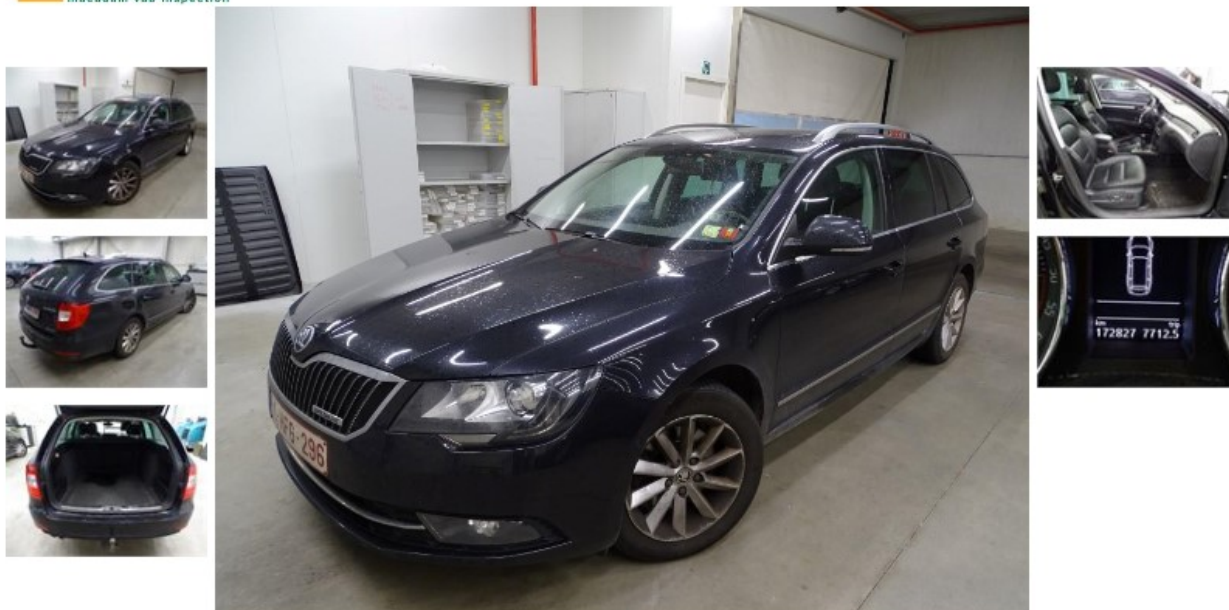
Vinnumber:	TMBJJ73T6F9009483	Versionname:	SUPERB COMBI GreenLine Elegance 105PK
First Registrationdate:	7/07/2014	Fiscalpower:	
Expertise Mileage:	172827	Power Kw:	77
Bodytype:	Break	Body color:	Black
Gearbox:	MAN 6 VIT	Paint type:	Metalic
Transmission:	Front	Rims summer:	Aluminium
Fueltype:	Diesel	Oil level:	OK
Battery functioning:	Yes	Parking lot:	3327
Number of doors:	5		
Number of seats:	5		
Number head rests:	5		
Rims summer:	Aluminium		
Category:	Passenger Car		
Oil level:	OK		
Registration Certificate Car (BE):	Yes
