**BMW 2 Active Tourer: 1JAL523**

**Limited Technical Inspection**

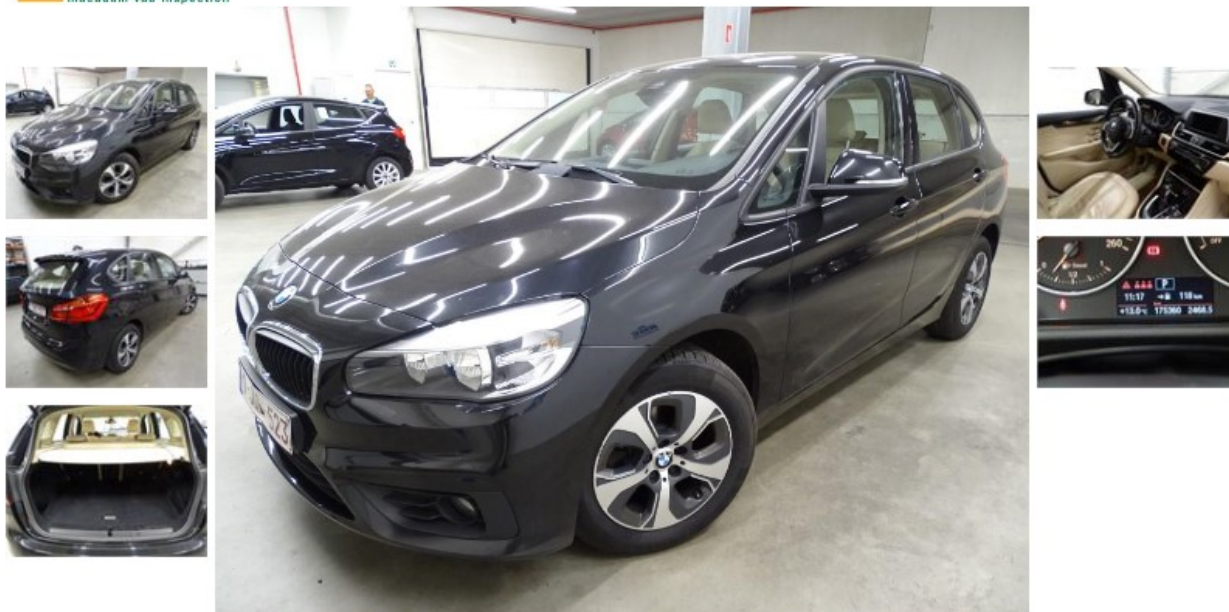
Total cost ex VAT	<b>2018,46</b>
Door F R, Scratch(es), Acceptable	<b>0,00</b>
<i>No pictures to display</i>	
Wing F R, Scratch(es), LI - Repair and paint (complete)	<b>220,18</b>
