**VOLKSWAGEN SHARAN: 1KNY582**

**Limited Technical Inspection**

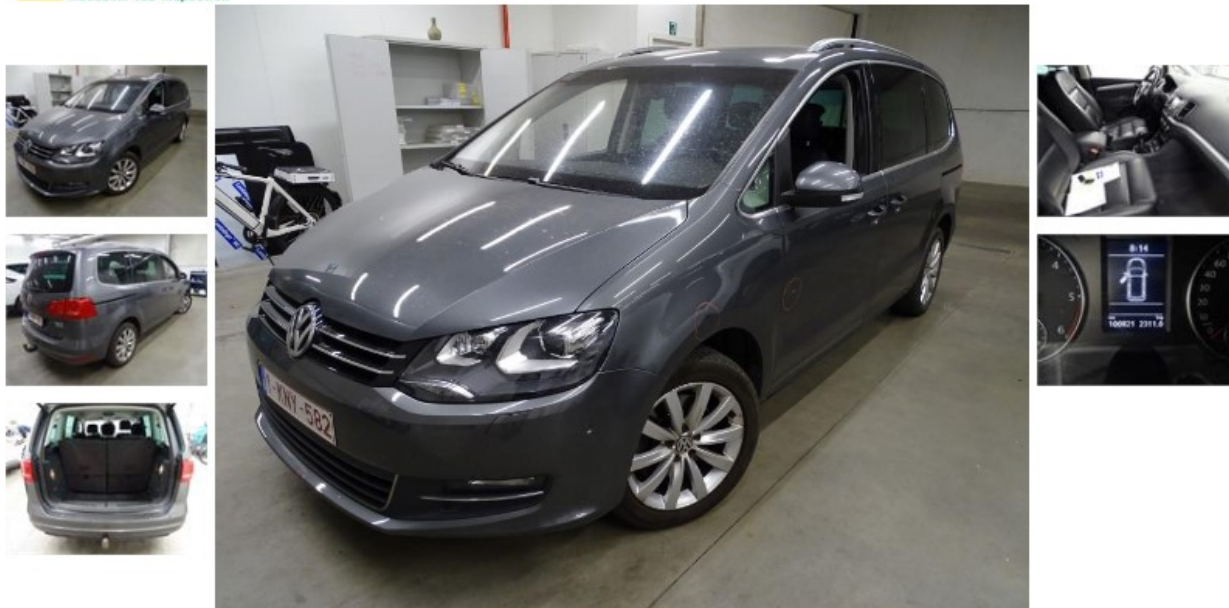
Total cost ex VAT	741,23
Bumper R, Scratch(es), Acceptable	0,00
<i>No pictures to display</i>	
Door F L, Dent(s) and scratch(es), LI - Repair and paint (complete)	382,02
