<b>MINI : 1PCU612</b>			
Vinnumber:	<b>WMWXN110503B51631</b>	Versionname:	<b>1.5 ONE D</b>
First Registrationdate:	<b>7/06/2016</b>	Fiscalpower:	
Expertise Mileage:	<b>110013</b>	Power Kw:	<b>70</b>
Bodytype:	<b>Hatchback</b>	Body color:	<b>Black</b>
Gearbox:	<b>MAN 6 VIT</b>	Paint type:	<b>Metallic</b>
Transmission:		Rims summer:	<b>Aluminium</b>
Fueltype:	<b>Diesel</b>	Oil level:	<b>OK</b>
Battery functioning:	<b>Yes</b>	Parking lot:	<b>1205</b>
Number of doors:	<b>3</b>		
Number of seats:	<b>5</b>		
Number head rests:	<b>5</b>		
Rims summer:	<b>Aluminium</b>		
Category:	<b>Passenger Car</b>		
Oil level:	<b>OK</b>		
Registration Certificate Car (BE):	<b>Yes</b>

<b>Limited Technical Inspection</b>			
Airco functioning	<b>OK</b>	Battery functioning	<b>Yes</b>
Tires wear profile	<b>OK</b>	Power steering	<b>Yes</b>
Idle position	<b>OK</b>	Sound engine	<b>OK</b>
Engine startingtime	<b>OK</b>	Clutch test	<b>OK</b>
Exhaust gass	<b>OK</b>	Wiper fluid level	<b>OK</b>
Handbrake	<b>OK</b>	Transmission	<b>OK</b>
		Lighting	<b>OK</b>
		Wiperblades	<b>OK</b>

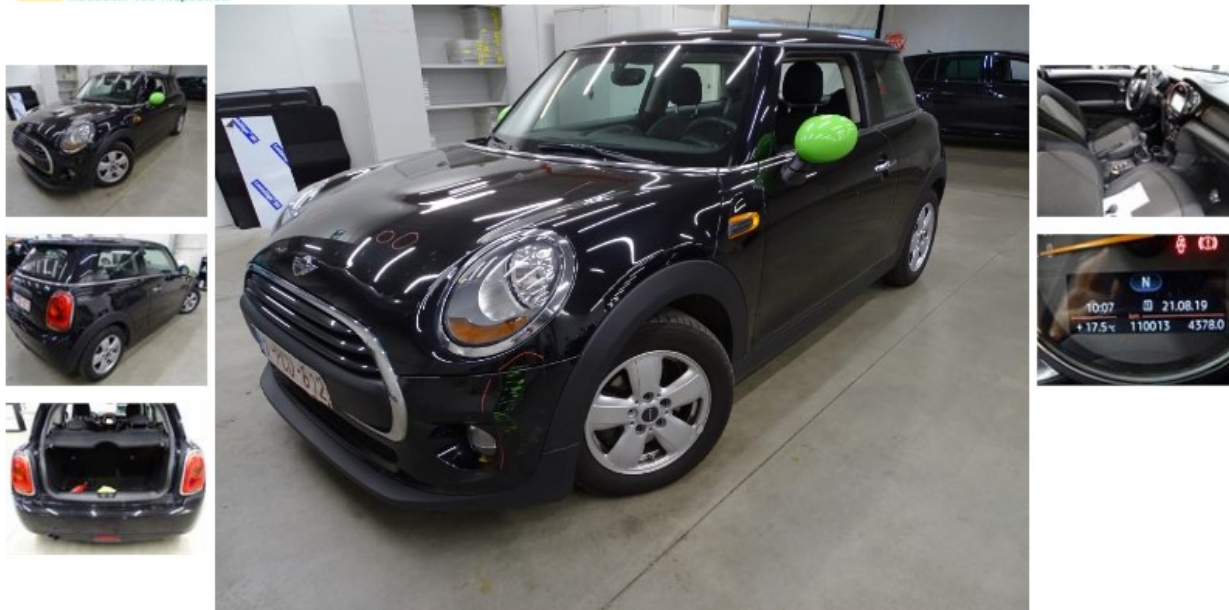
<b>Assistance equipment</b>			
Repair kit	<b>Yes</b>	Compressor	<b>Yes</b>
<b>Total cost ex VAT</b>			<b>691,88</b>
<b>Alloy rim R R, Scratch(es), LI - Repair and paint (complete)</b>			<b>95,00</b>
