FORD Galaxy: 1DNW121			
Vinnnumber:	WF0MXXGBWMCK24583	Versionname:	GALAXY Econetic Trend St&St DPF 115PK
First Registrationdate:	3/07/2012	Fiscalpower:	
Expertise Mileage:	149584	Power Kw:	85
Bodytype:	Minibus	Body color:	Grey
Gearbox:	MAN 6 VIT	Paint type:	Metalic
Transmission:	Front	Rims summer:	Aluminium
Fueltype:	Diesel	Oil level:	NOT OK
Battery functioning:	Yes	Parking lot:	511
Number of doors:	5		
Number of seats:	7		
Number head rests:	7		
Rims summer:	Aluminium		
Category:	Passenger Car		
Oil level:	NOT OK		
Registration Certificate Car (BE):	No

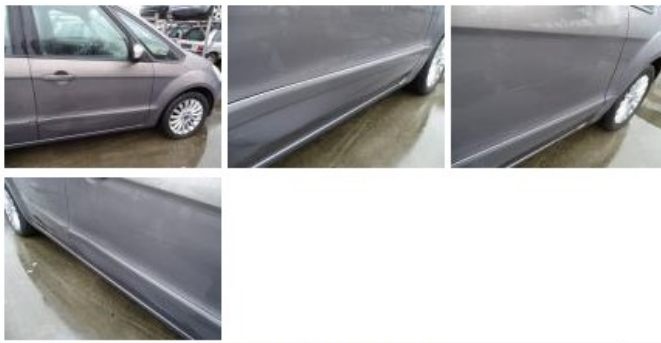
Certificate Of Conformity, Missing, E - Replace	0,00
<i>No pictures to display</i>	
Door F R, Bump(s) and scratch(es), LI - Repair and paint (complete)	382,02

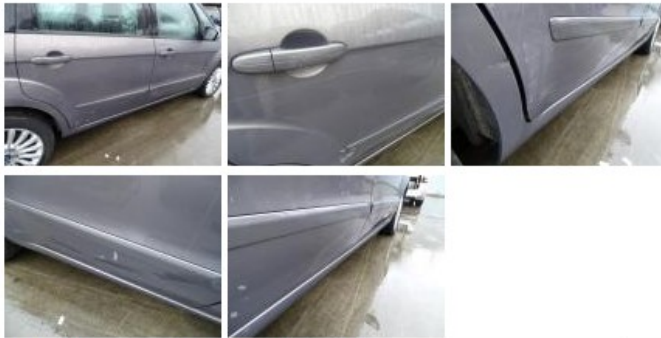
Door R R, Bump(s) and scratch(es), LI - Repair and paint (complete) 382,02
