**VOLKSWAGEN Passat: 1FXC392**

**Limited Technical Inspection**

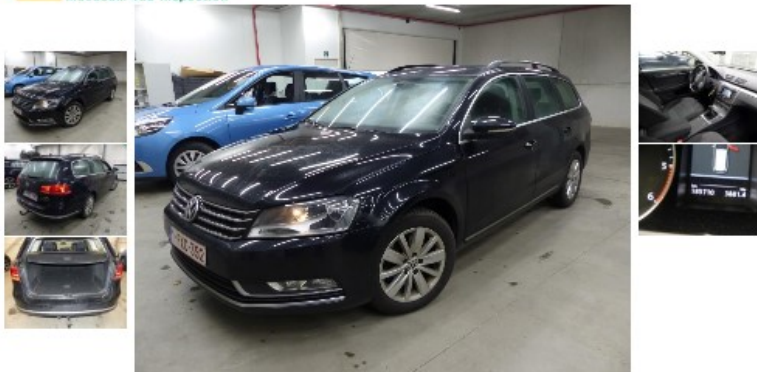
Vinnnumber:	<b>WVWZZZ3CZEE080394</b>	Versionname:	<b>PASSAT VAR Comfortline BMT 105PK</b>
First Registrationdate:	<b>25/11/2013</b>	Fiscalpower:	
Expertise Mileage:	<b>185710</b>	Power Kw:	<b>77</b>
Bodytype:	<b>Break</b>	Body color:	<b>Black</b>
Gearbox:	<b>MAN 6 VIT</b>	Paint type:	<b>Metalic</b>
Transmission:	<b>Front</b>	Rims summer:	<b>Aluminium</b>
Fueltype:	<b>Diesel</b>	Oil level:	<b>OK</b>
Battery functioning:	<b>Yes</b>	Parking lot:	<b>2326</b>
Number of doors:	<b>5</b>		
Number of seats:	<b>5</b>		
Number head rests:	<b>5</b>		
Rims summer:	<b>Aluminium</b>		
Category:	<b>Passenger Car</b>		
Oil level:	<b>OK</b>		
Registration Certificate Car (BE):	<b>Yes</b>
